NATF Redacted Operating Experience Report

Safety – Concrete Pole Accident

Concrete Pole Accident

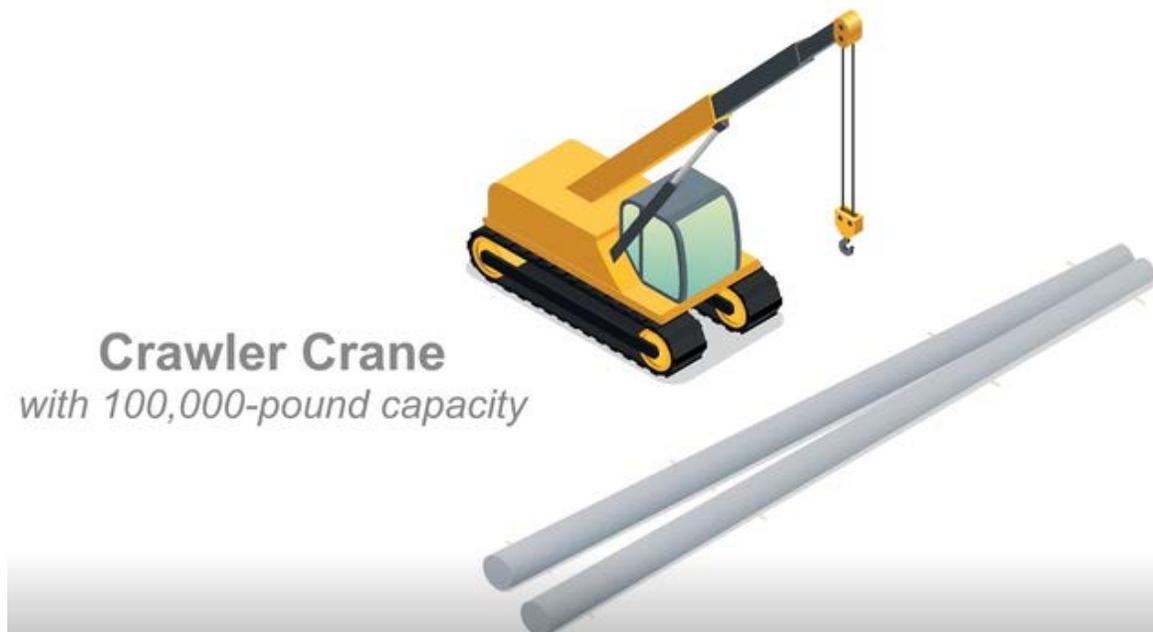
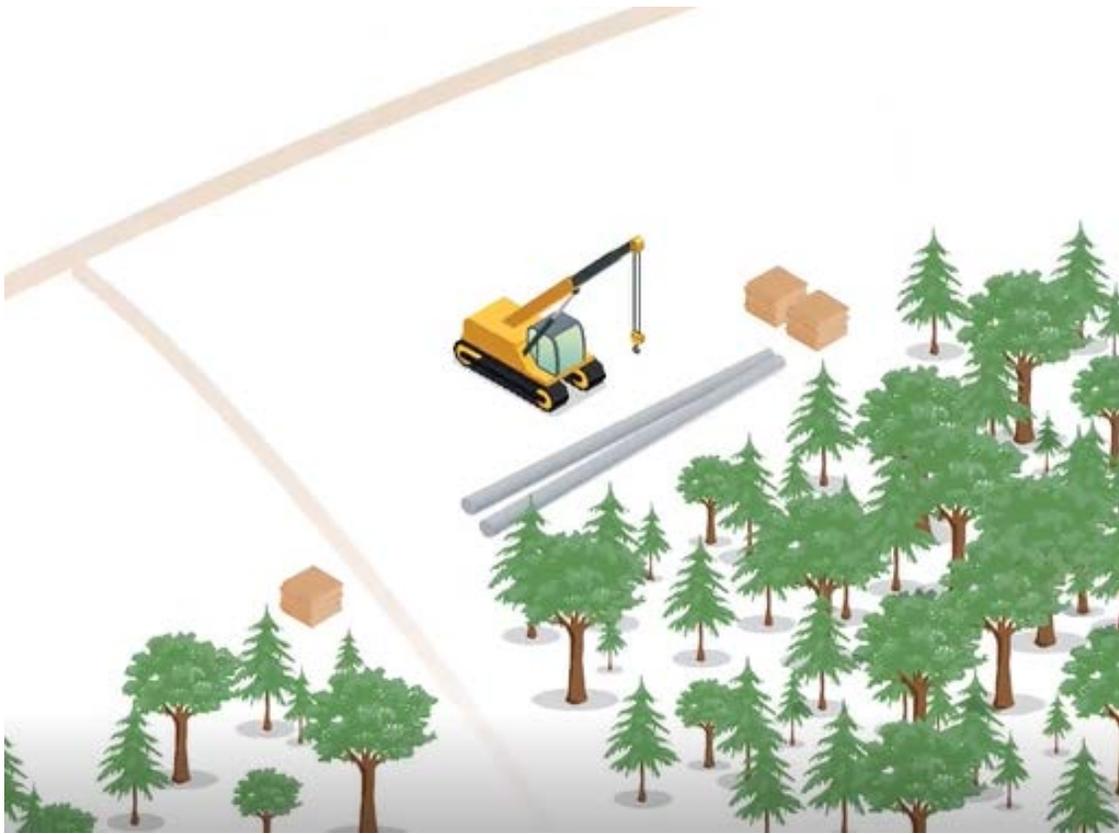
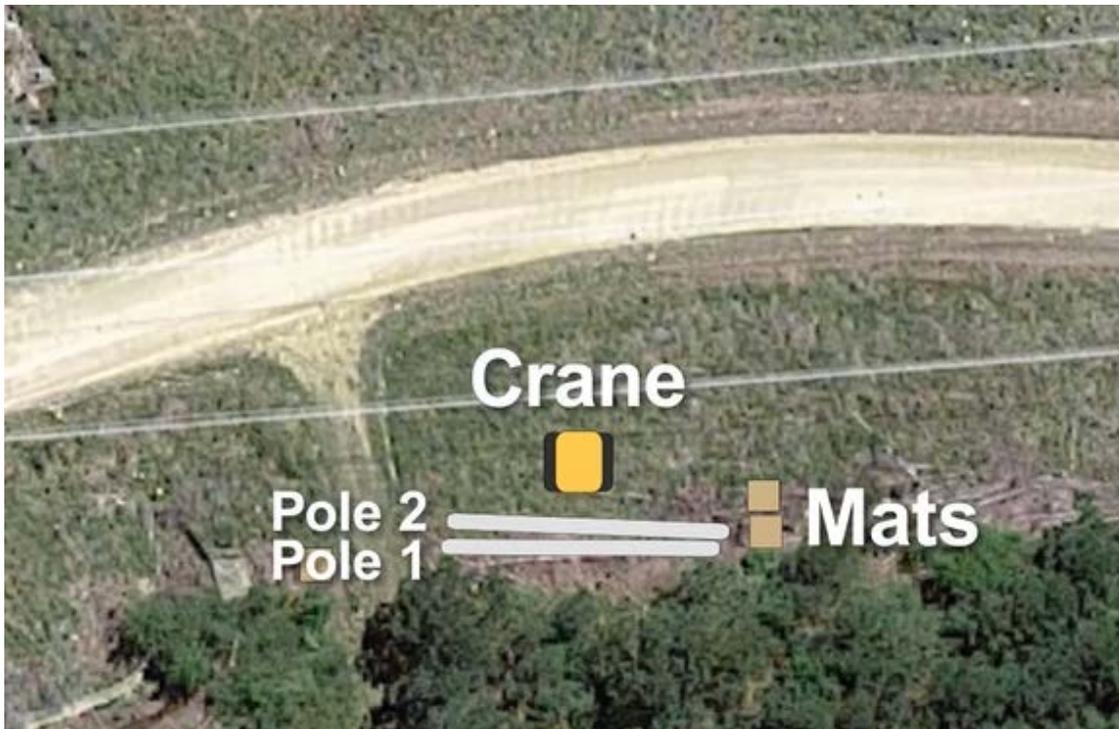
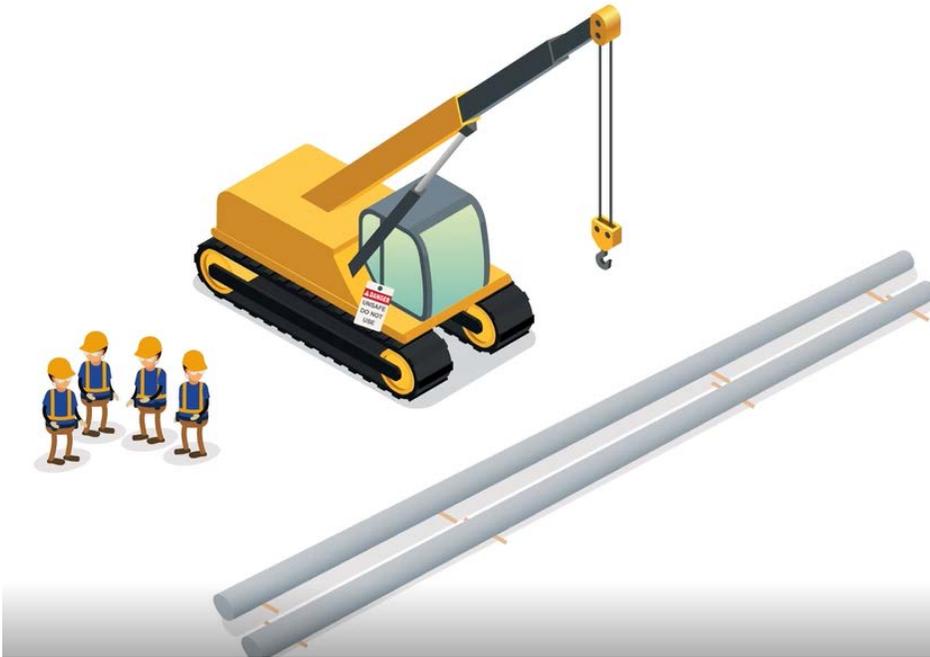
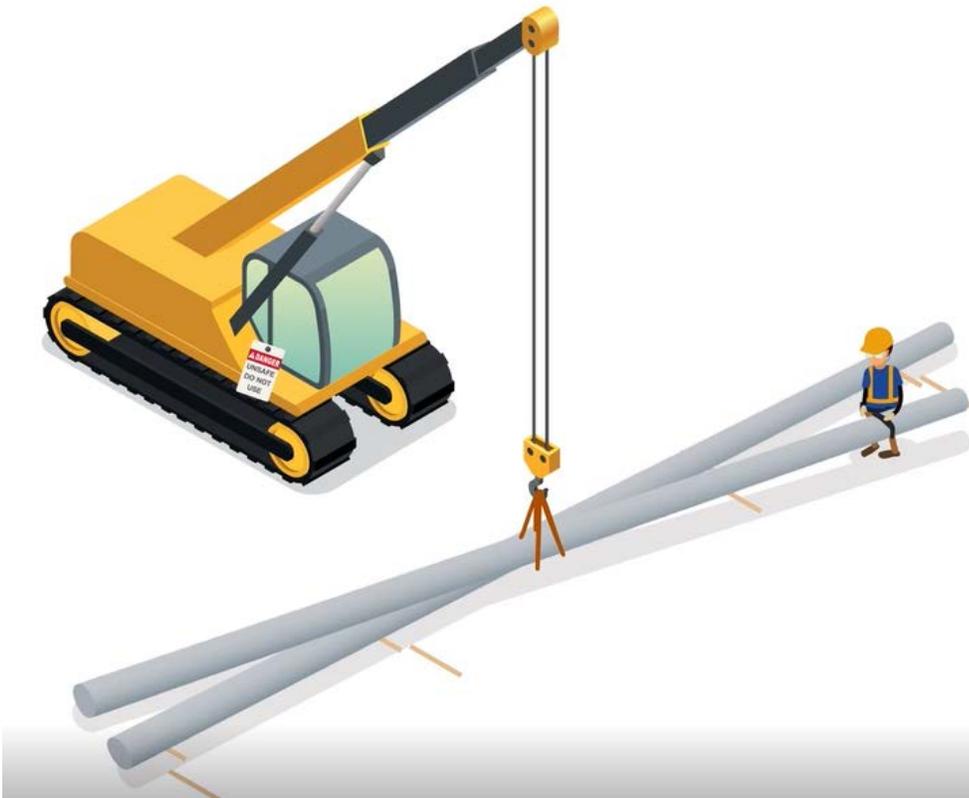
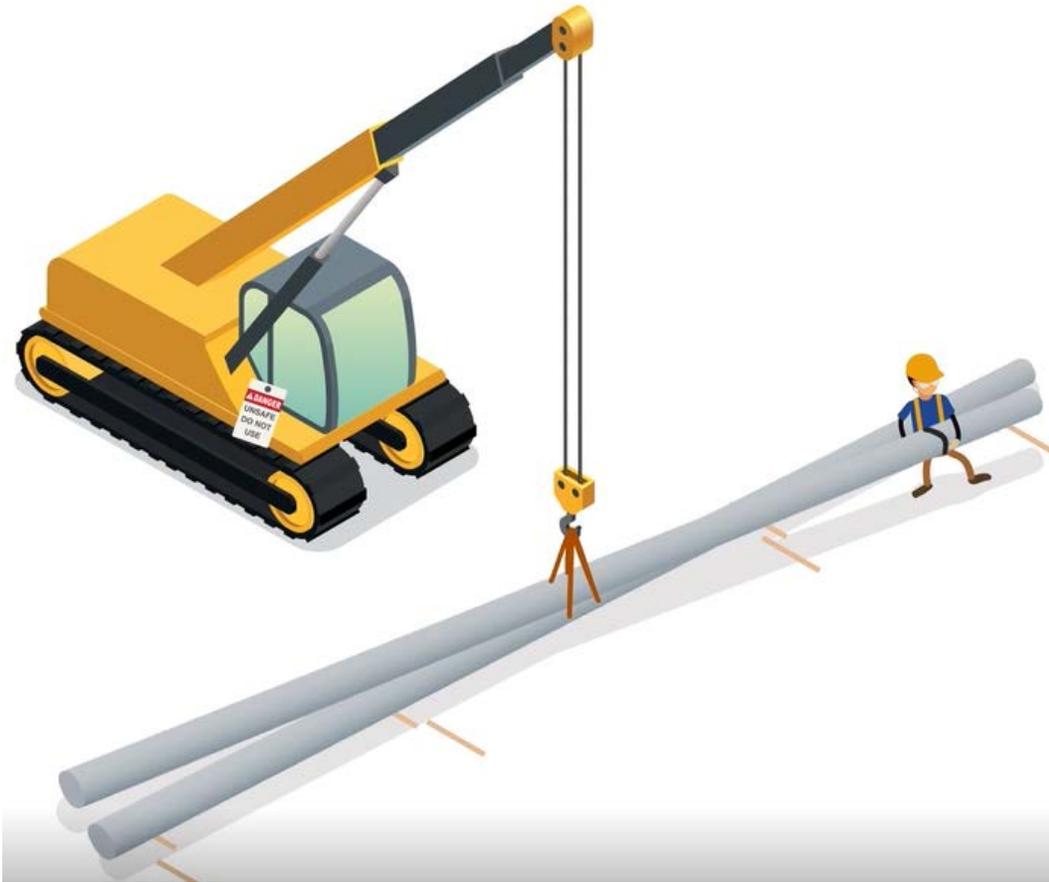
The crew reminded the foreman of the problem with the crane. However, the foreman stated he would load the poles and then place the crane out-of-service afterward. One of the poles was being partially lifted in the air by the crane. At that time, the foreman directed a crew member to retrieve and install a tag line. While the crew member was installing the tag line, the pole tilted and slipped. The crew member was caught between the two concrete poles. His leg was pinned and he encountered a severe injury. Emergency services were called. A second crew member was injured during rescue activities.

The following pictures provide a representation of the accident.
