# NATF Redacted Operating Experience Report

## Conductor Broke When Increasing Tension

Conductor Broke When Increasing Tension

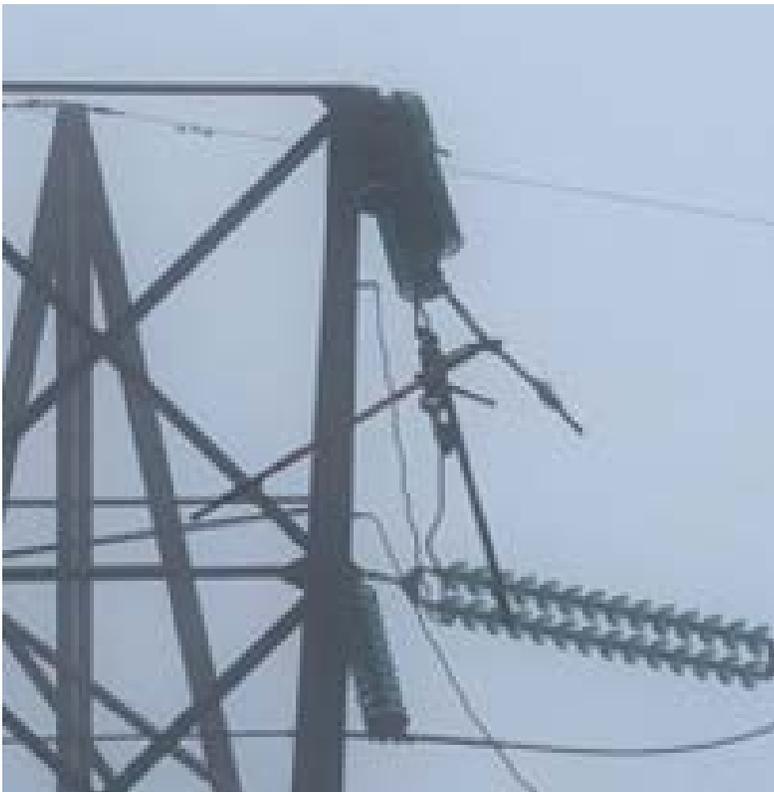
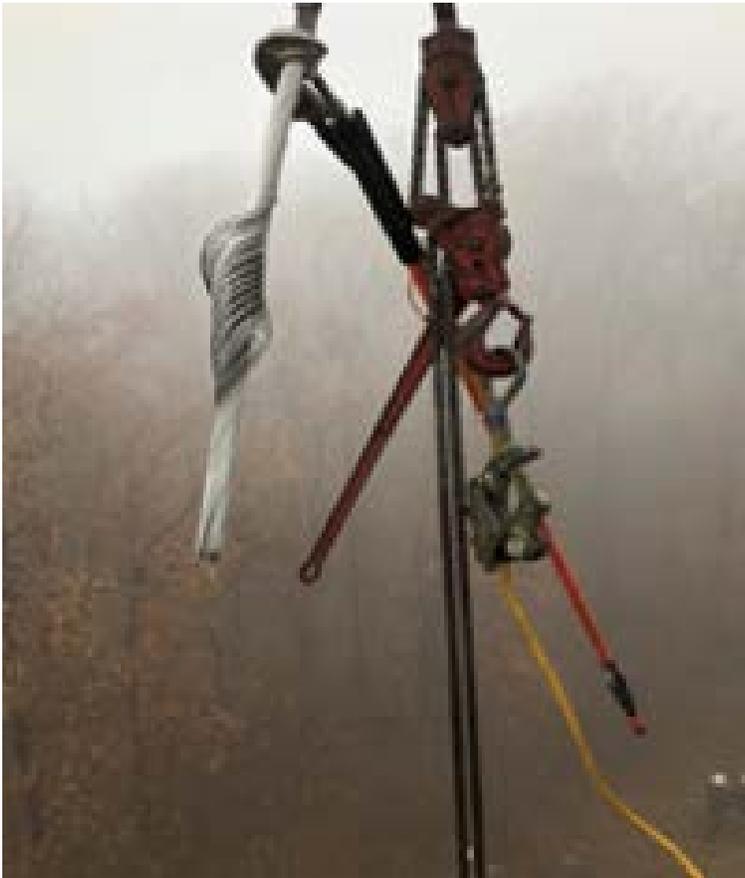
A conductor broke while a line crew was working on a 161 kV line. No one was injured.

The crew's task was to add 18 inches of slack in a span that had increased in tension due to one of the structures slowly sliding or moving over the past 40+ years. The linemen had the wire held at the dead-end structure with a 6-ton hoist and conductor grip. The crew was about to disconnect the insulator string and add the hardware for 18 inches of slack when the conductor broke near the conductor grip. The linemen were working from a bucket truck and were not positioned in the bite of the conductor when it broke.

It was determined that the conductor tension was near its breaking strength and was too high to remove with traditional rigging methods. Our company decided to hire a specialized blasting company to implode the remaining conductors from the tower.

1. Stopped work on the line and investigated the incident.
2. Worked with management to keep the circuit energized, which created heat in the conductor to reduce the actual tension until the lines could be replaced safely.
3. Coordinated with appropriate groups to ensure the remaining lines were safely removed.
