NATF Redacted Operating Experience Report

Electrical Contact Incident during Underground Cable Replacement

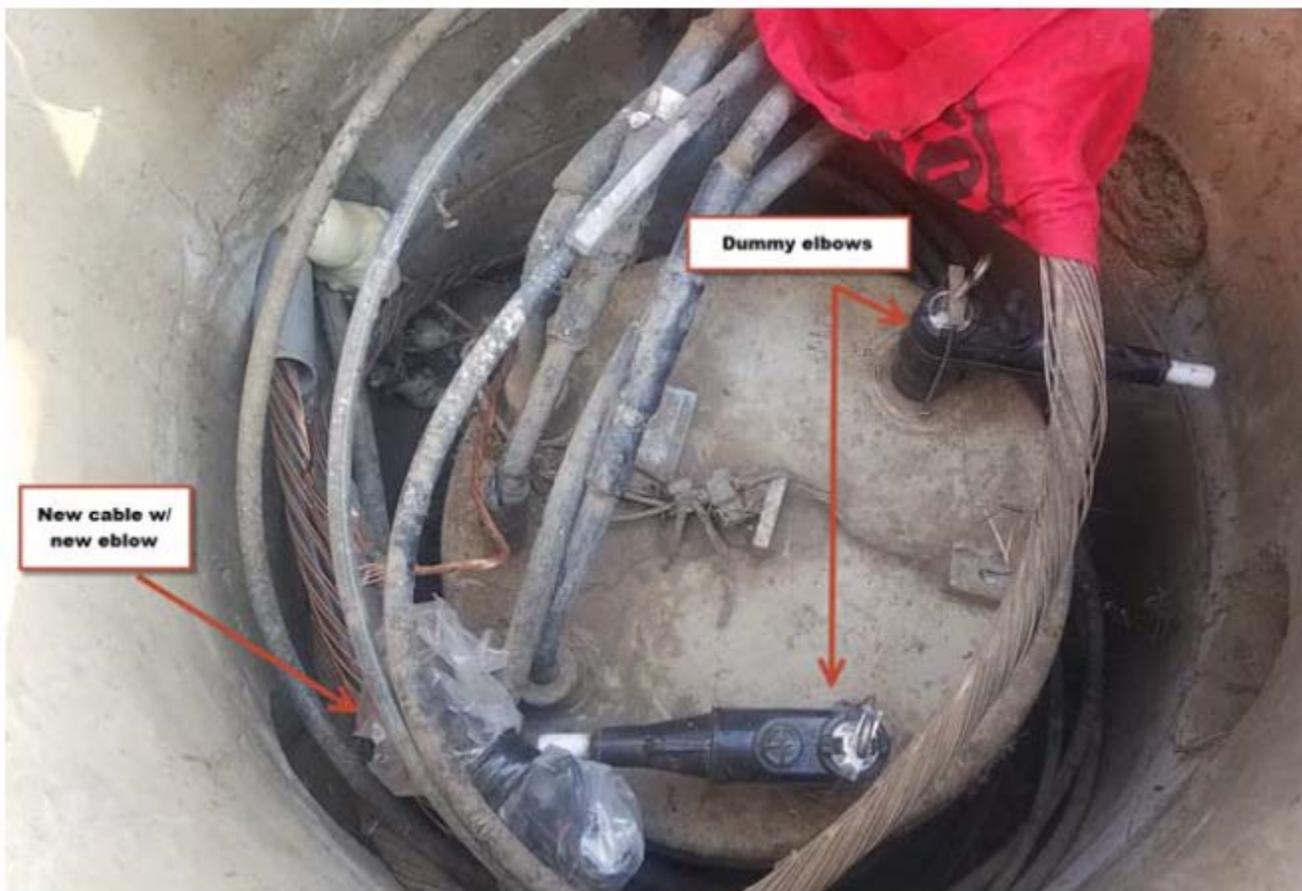
Associated Picture

While waiting for the replacement linemen, the foreman and groundman remained at the job site and began to prepare the site for the replacement linemen by making up the elbow on the end of the cable that was laying outside of the transformer. After making up the elbow, the foreman began coiling new primary cable and determined he needed to climb inside the BURD transformer enclosure. He utilized a hot-stick to free the cable from the secondary conductors. While working from atop the transformer, the foreman made inadvertent electrical contact. He sustained significant burn injuries to his hand, arm, and leg. The foreman was eventually able to return to work.

This incident had two apparent causes and one contributing cause. Apparent cause 1 was the loss of focus on safe work practices; instead, the focus was placed on productivity. Apparent cause 2 was that the accepted work practice used did not mitigate the hazard. The contributing cause was the decision to continue working without waiting for the other linemen to arrive.

1. Implementing a job aid for connecting generators to BURD transformers that will eliminate the hazard when applicable.
