NATF Redacted Operating Experience Report

Stored Energy Causes Switch Handle to Strike Employee

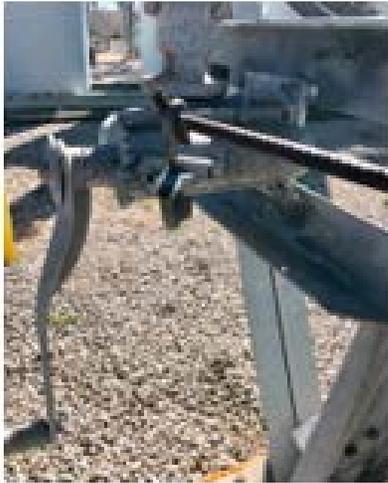
Remove the lock with
the lifting tool

- Using the device currently in place for lifting cable trench covers, personnel operating the hand-crank gang-operated switches are able to stay well away and out of the line of fire.

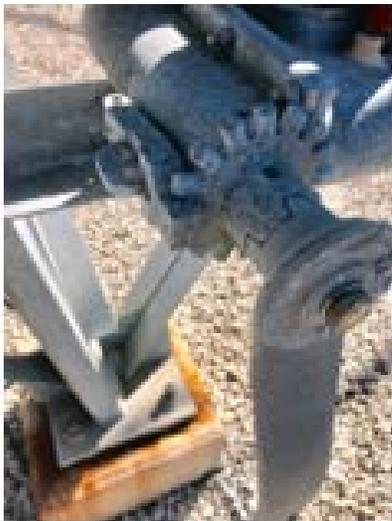
Close-up view of
locking mechanism

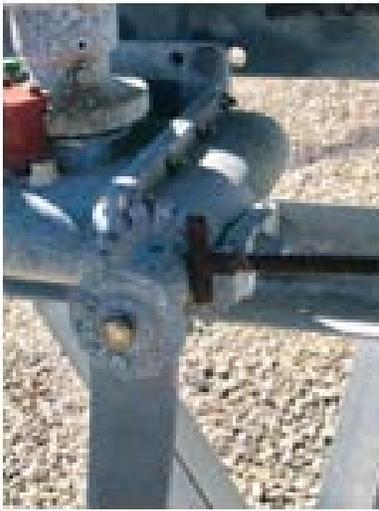
Pull tab back to
release gear with
lifting tool

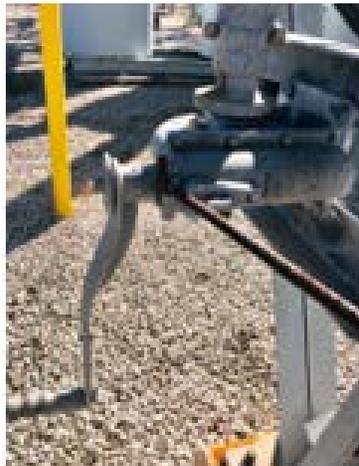
From Switchman's view
using lifting tool
