NATF Redacted Operating Experience Report

Safety – Transmission Tower Climber

Individual Climbing Tower

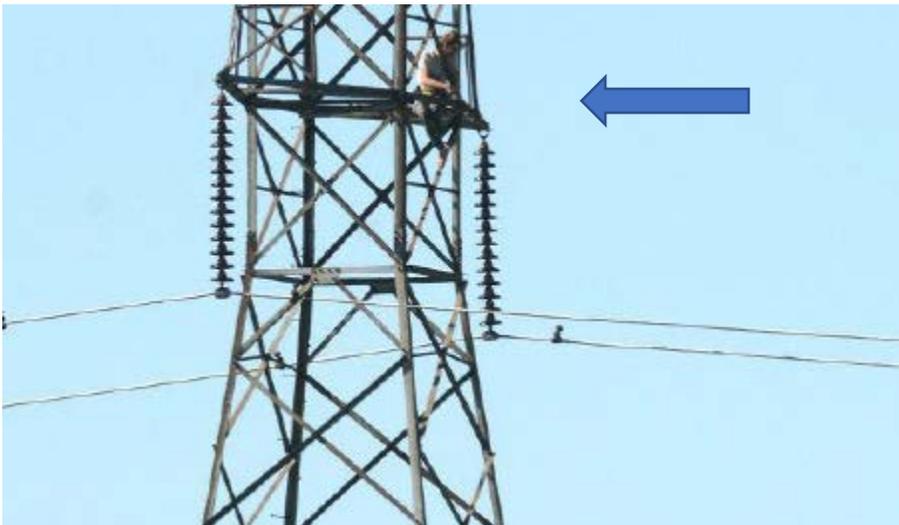
Emergency personnel were able to safely secure the individual and remove him from the tower using the fire department’s aerial platform truck.
