# NATF Redacted Operating Experience Report

## Distribution Circuit Trips When Pulling 138 kV Conductor

Distribution Circuit Trips When Pulling 138 kV Conductor

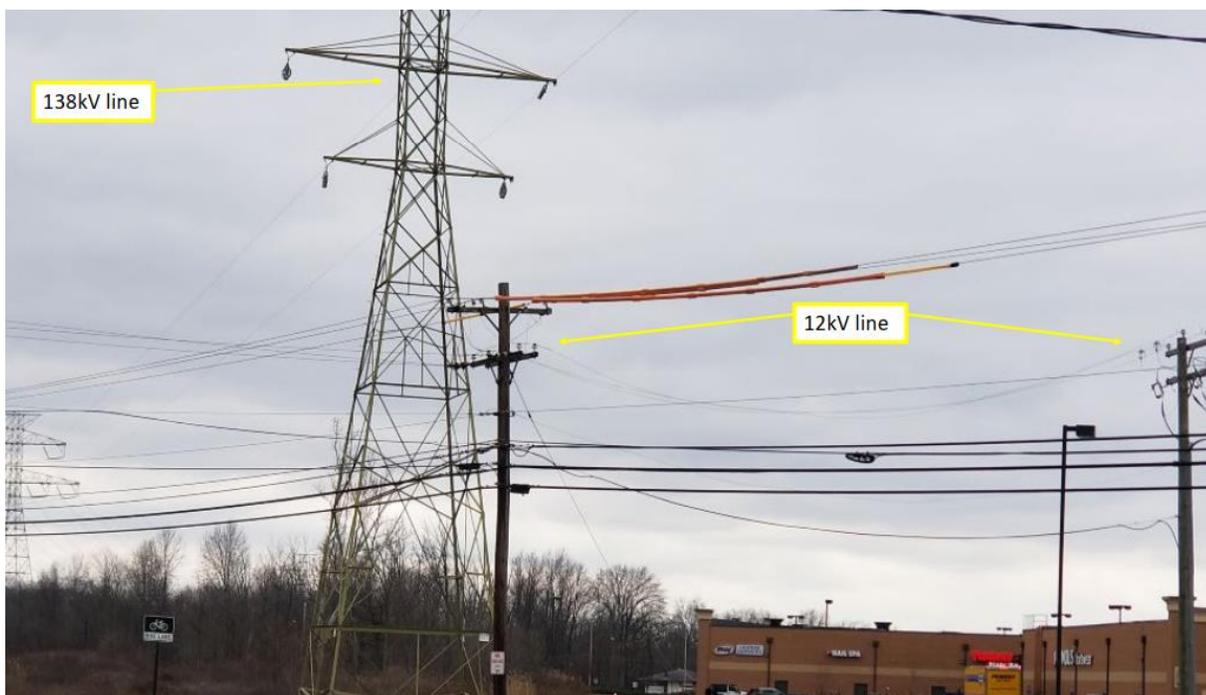
Crews were attempting to chase spider rope on a section of a 138 kV line. While crossing an intersection, the wind blew the rope away from two mobile guard structures causing two phases to contact with the slack span. This event impacted 1600 customers for a period of 33 minutes.

1. High winds were the major contributor to this event.
2. The slack span was not covered. It was determined that having a cover on the slack span would have created more of a hazard on the line by causing the phases to slap together.

- Delayed job until the wind calmed down.
- Changing approach for future work: will position a lineman in a bucket truck to pass spider rope over slack span.
- Sharing this report with appropriate personnel.
