NATF Redacted Operating Experience Report

Bucket Truck Rollover

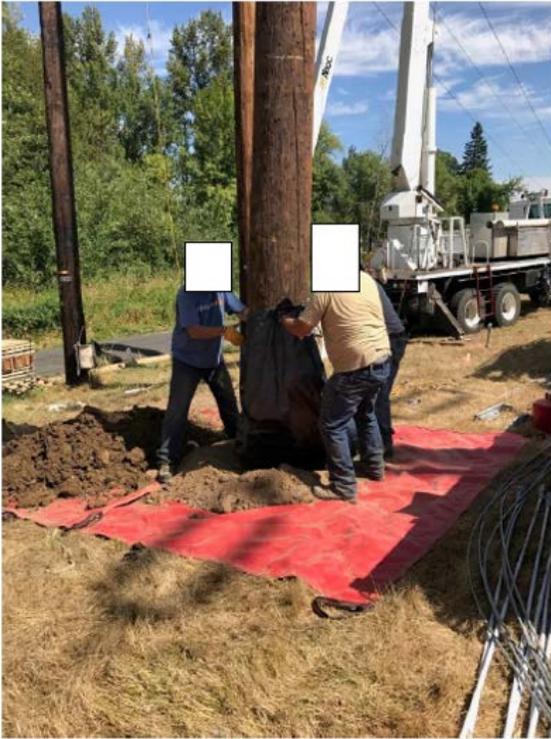
At 13:18, TLM crew 2 setting poles

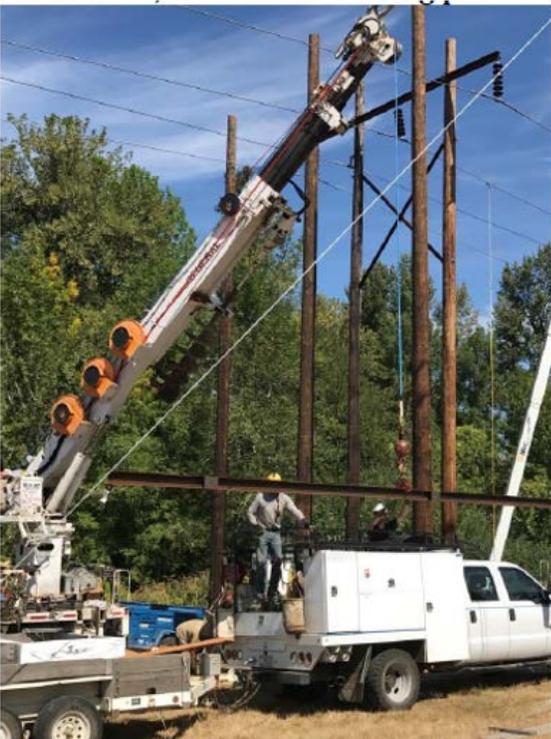
At 13:32, TLM crew 2 installing crossarm

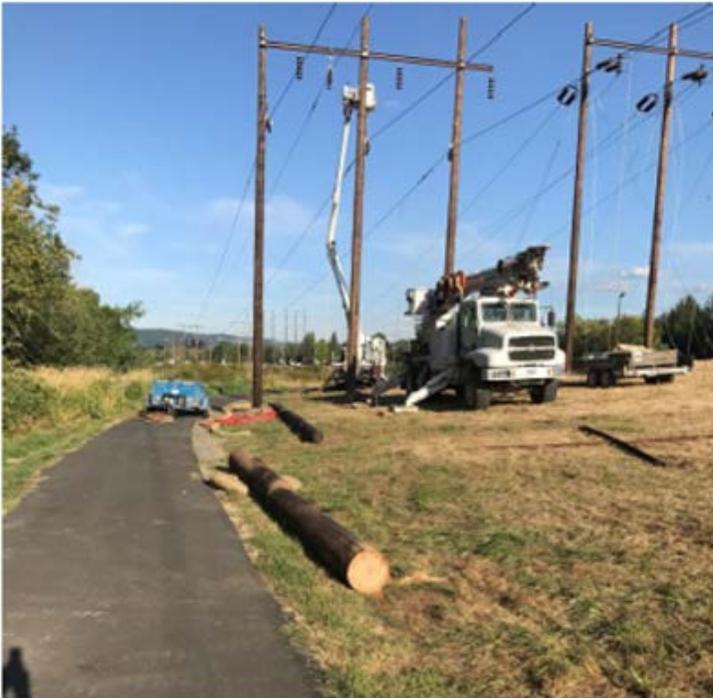
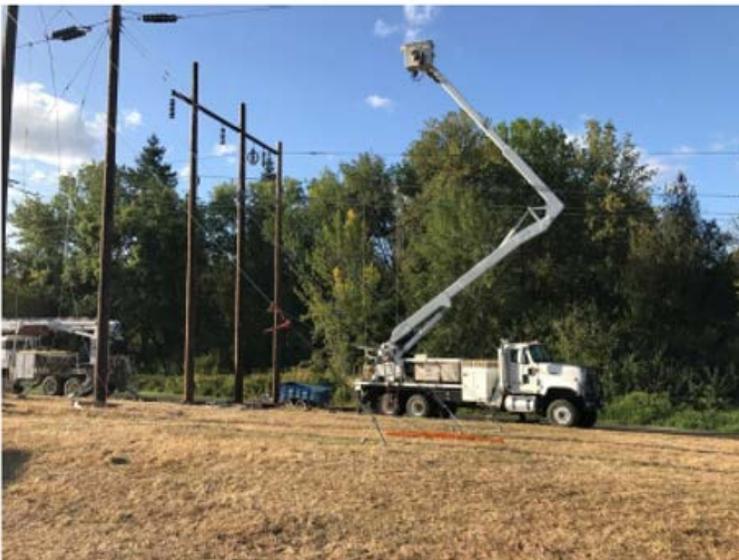
At 18:16, the stored boom between conductors is greater than 50-feet above ground for tool theft protection. Note that truck is set on a double slope, with an approximate 5-degree drop from back of truck to front of truck and a 5-degree drop from curb side (passenger side) to street side (driver side).

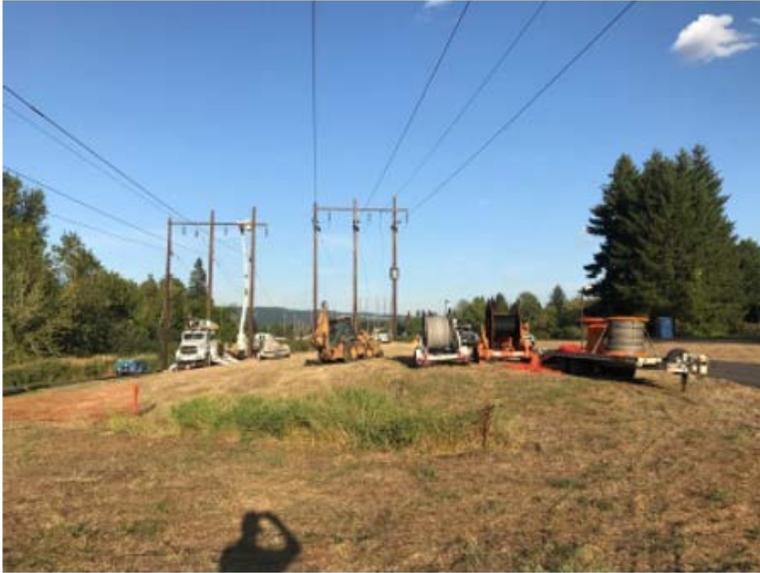
18:23: last known photo of incident site looking to the east

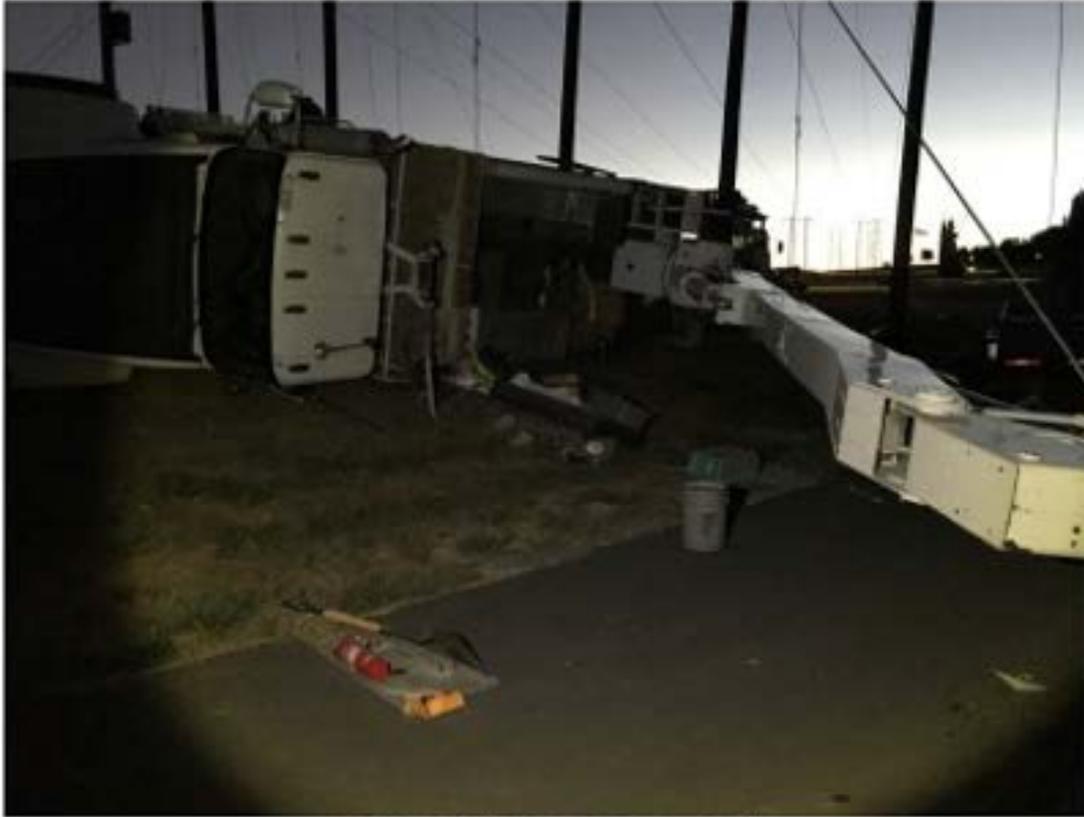
8/30/2017 20:35

At approximately 19:23, the boom descended toward the low side, contacted two conductors and the fiber line, and pinned them toward the ground. The bucket truck came to rest on to the street side (driver side) with the boom falling across a barricaded paved walking trail, with the upper boom and bucket landing in heavy brush.
