NATF Redacted Operating Experience Report

Dropped Ram during Structure Jacking

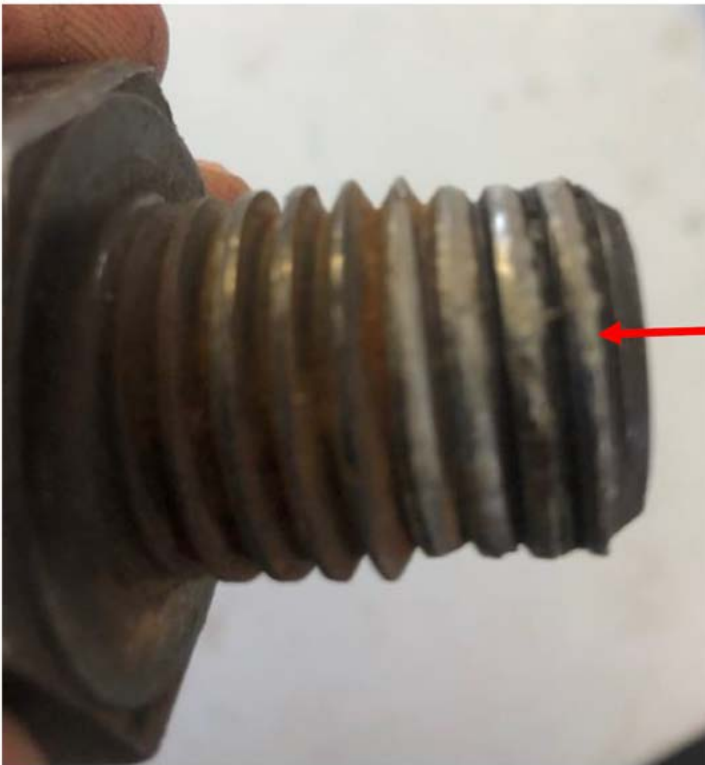
While in the process of using a hydraulic ram to force two transmission tower sections together (jacking), the ram broke loose from the structure and fell 35 feet to the ground. The contractor found the threads stripped out on the 1" X 1" bolts that hold the jacking plate in place and on the nuts that were welded to the structure by the manufacturer.

- Possible wear of bolts from multiple previous uses.
- Possible defect of nut welded to structure by manufacturer.
- Improper mounting of jacking plate.

4 stripped threads

- Reinforced the importance of always reviewing line of fire and drop zone hazards.
- Ensure proper mounting of jacking plate to ensure forces are transferred across the jacking nuts welded to the pole section as expected. Proper mounting includes ensuring welded jacking nuts are properly spaced within the required tolerance. The treads should see minimal forces if the jacking plates are mounted properly.

1. Reminding and encouraging crews to always stay out of fall zone.
2. Replacing jacking bolts in all five jacking kits used by the contractor.
3. Developing lessons learned from this near miss.
4. Procuring thread gauges for jacking bolts.
5. Stocking each jacking kit with a threading gauge to allow better inspection of bolts.
6. Developing bolt-changeout requirement.
7. Communicated proper mounting of the jacking plates to the pole section.
