# NATF Redacted Operating Experience Report

## Faulty Safety Rope Discovered During Training

Faulty Safety Rope Discovered During Training

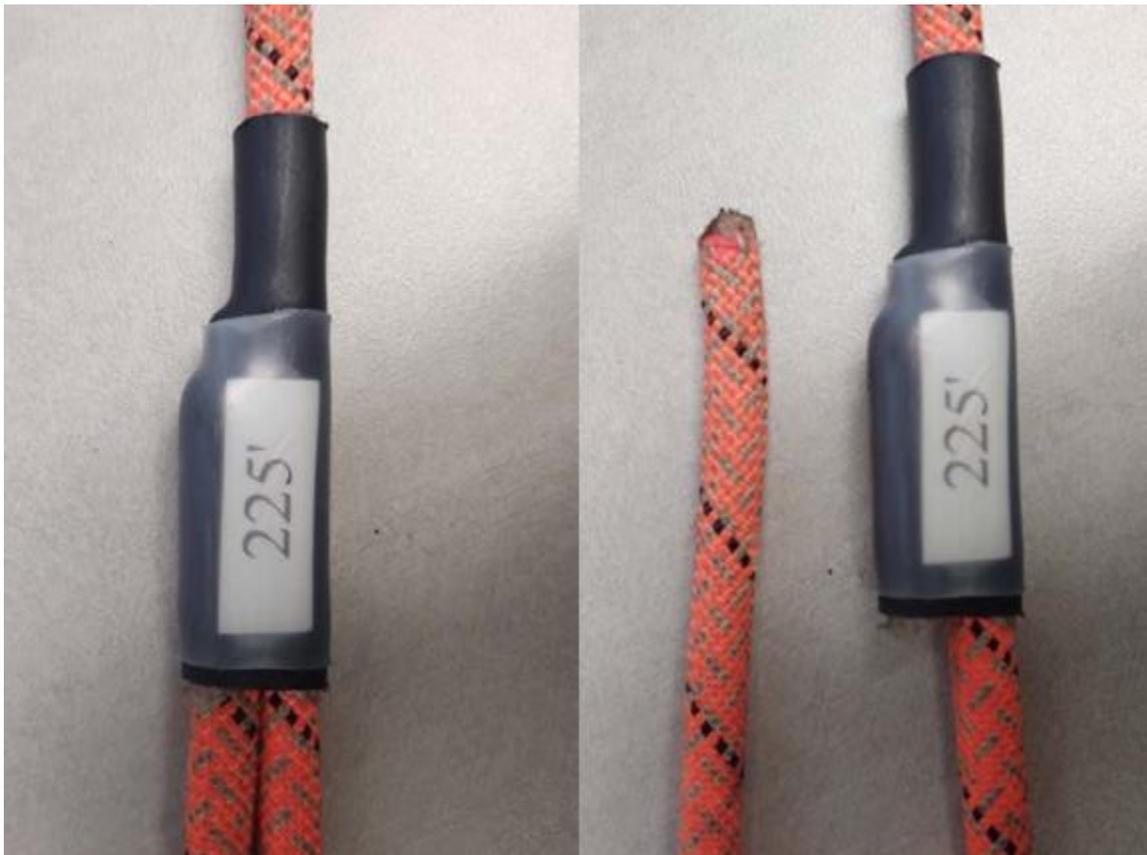
This report pertains to a safety rope that was removed from service due to being modified in-house. The rope, discovered during training, had been modified in such a manner that it gave the appearance of a factory termination. The rope had been cut to a custom length, looped into an eye, and shrink tubed. The rope did not have any stitching and did not have the approved knot to secure the eye. The loop was only held in place by the glue in the shrink tube. This could have resulted in a serious incident.

A safety alert was issued with the expectation that the alert will be reviewed at the next safety meeting and inspections of like equipment will be performed prior to the next use.

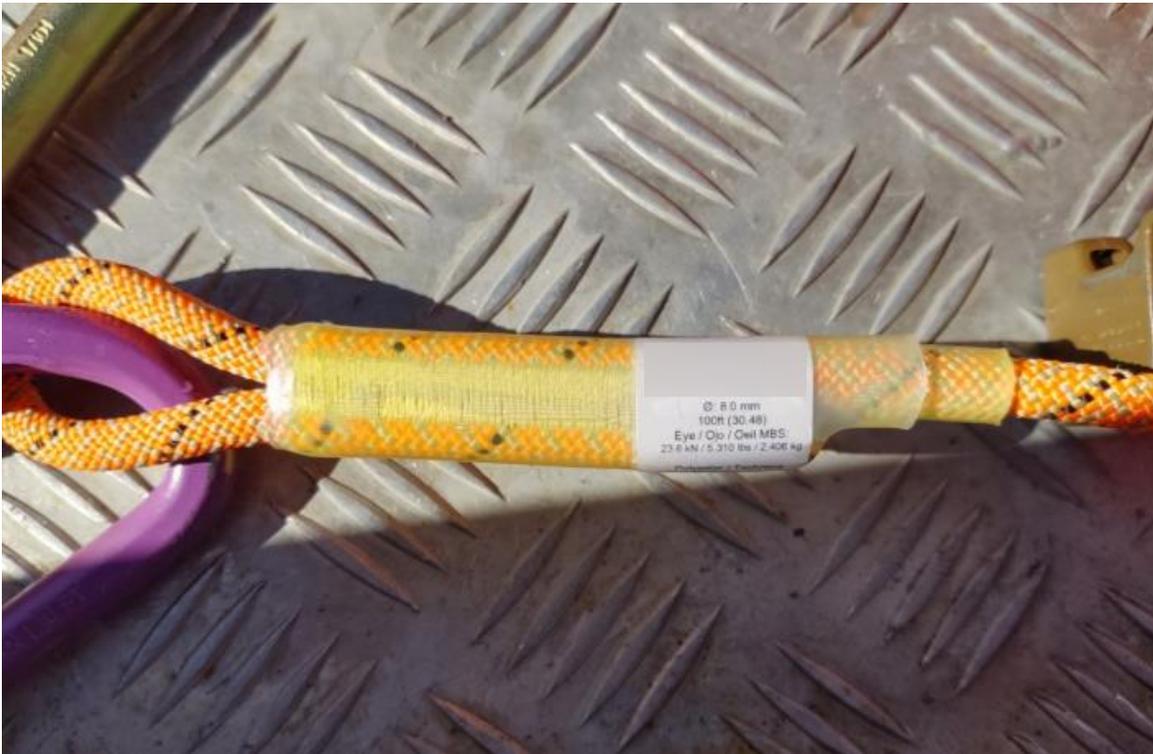
This type of rope comes from the manufacturer with a factory termination as shown in the picture below. The factory termination will always come with a clear shrink tube to allow for inspection of the termination stitching. In addition, the tag placed under the shrink tube contains the manufacture date, size, length, strength, and lot number.
