# NATF Redacted Operating Experience Report

## Near Miss – Incomplete Switching and Tagging for Neighboring Utility

Near Miss – Incomplete Switching and Tagging for Neighboring Utility

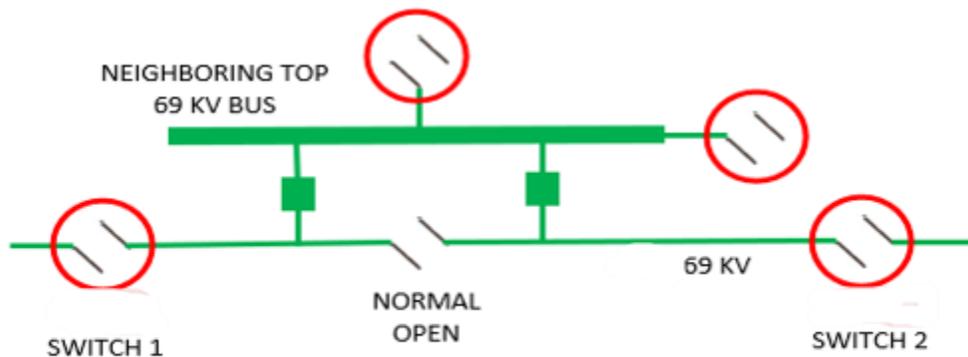
**Figure 1: Planned Clearance Zone**

Our company and a neighboring transmission operator (TOP) had scheduled maintenance in the vicinity of a 69 kV bus that is owned and operated by the neighboring TOP. The clearance zone included the 69 kV bus and two three-phase, gang-operated switches (see switch 1 and switch 2 in figure 1 below) on our 69 kV lines that terminated at the neighboring TOP's 69 kV bus. The switches were to have our company hold cards placed for our transmission construction personnel and hold cards for the neighboring TOP because both companies had construction/commissioning work to complete.

Our TOP incorrectly issued our company hold cards to the neighboring TOP prior to our switches being opened or hold carded. The issued switch order was still in progress. This resulted in a near miss when the neighboring TOP field staff tested the connections to our 69 kV line and found the line energized at nominal voltage.

Our switch person then contacted our TOP reporting that the neighboring TOP's field staff were issued a clearance from their System Operator, and when the line was tested, they found voltage still present. Our switch person noted that he had not completed his switch order and that switch 1 and switch 2 were still closed. Our TOP realized his mistake and contacted the neighboring TOP to report the error.

2. The switch order record has been modified to insert a human performance critical step in the switching/tagging process. The critical step will prompt our TOP to perform a verification check that all switching and tagging steps have been completed prior to issuing a clearance to our personnel or hold cards to a neighboring utility control center.
