NATF Redacted Operating Experience Report

Pole Slide Incident

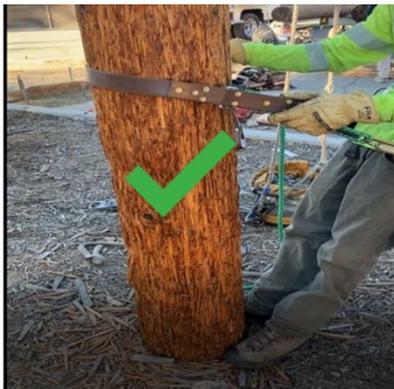
Fig. 1. Falling back position; gaffs 30-45 degrees

1. Apply the following when climbing a pole:
 - a. Slow down and stay focused on your body position.
 - b. Maintain a proper gaff angle (30-45 degrees) to ensure gaffs are fully engaged in the pole and maintain proper tension.
 - c. Adhere to basic climbing principles, even with new equipment and techniques.
2. Remember every action has a reaction.
3. Adjust FRE to manufacturer's instructions.

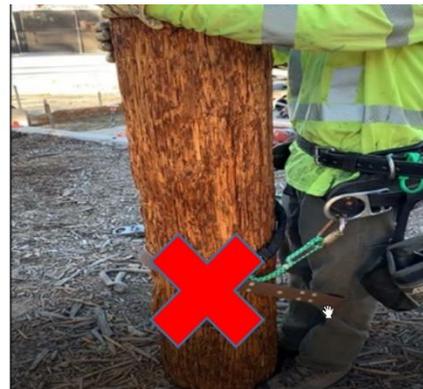
Fig. 2. Body into the pole; parallel gaffs
