NATF Redacted Operating Experience Report

Roll Away ATV in Right-of-Way

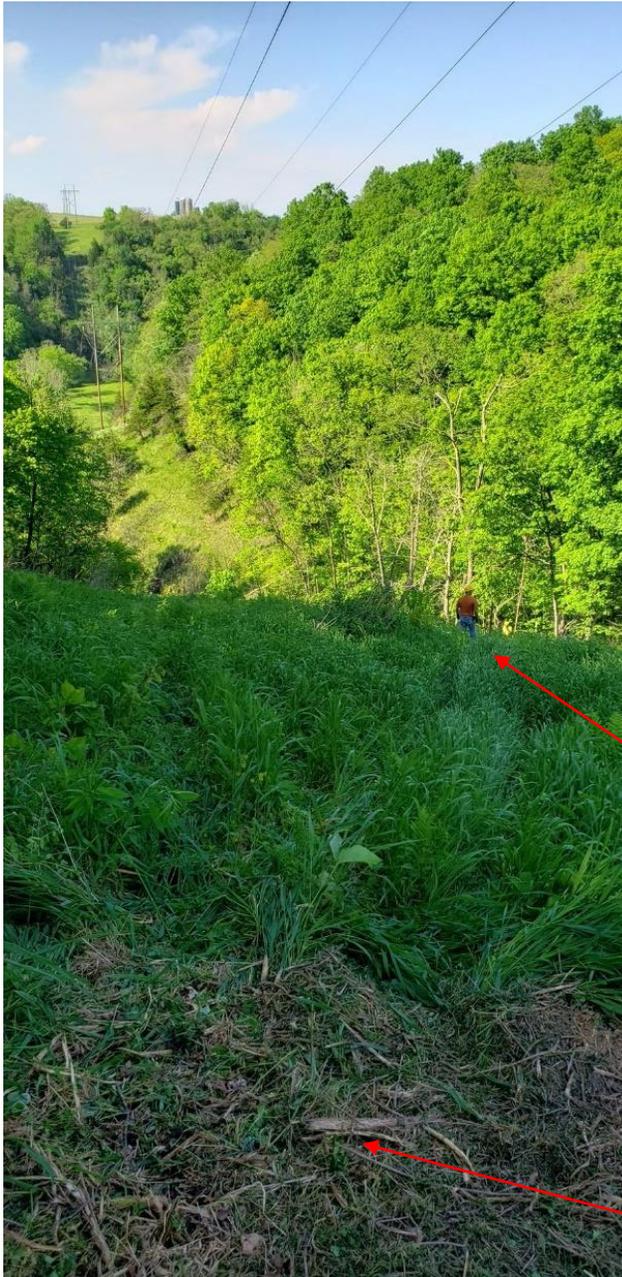
Path of Travel

Relocated
Location of ATV

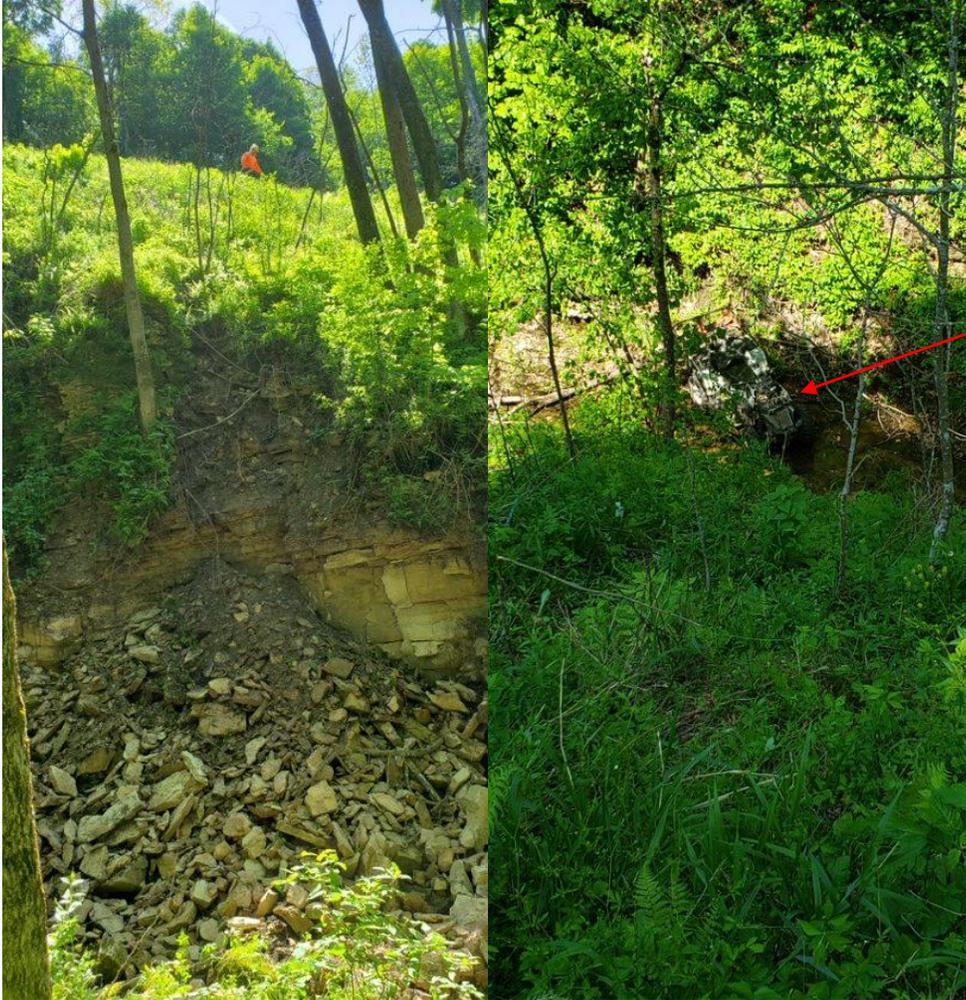
View from the top, looking down into the ravine at damaged vehicle
