# NATF Redacted Operating Experience Report

## Substation Employee Fall Incident

Substation Employee Fall Incident

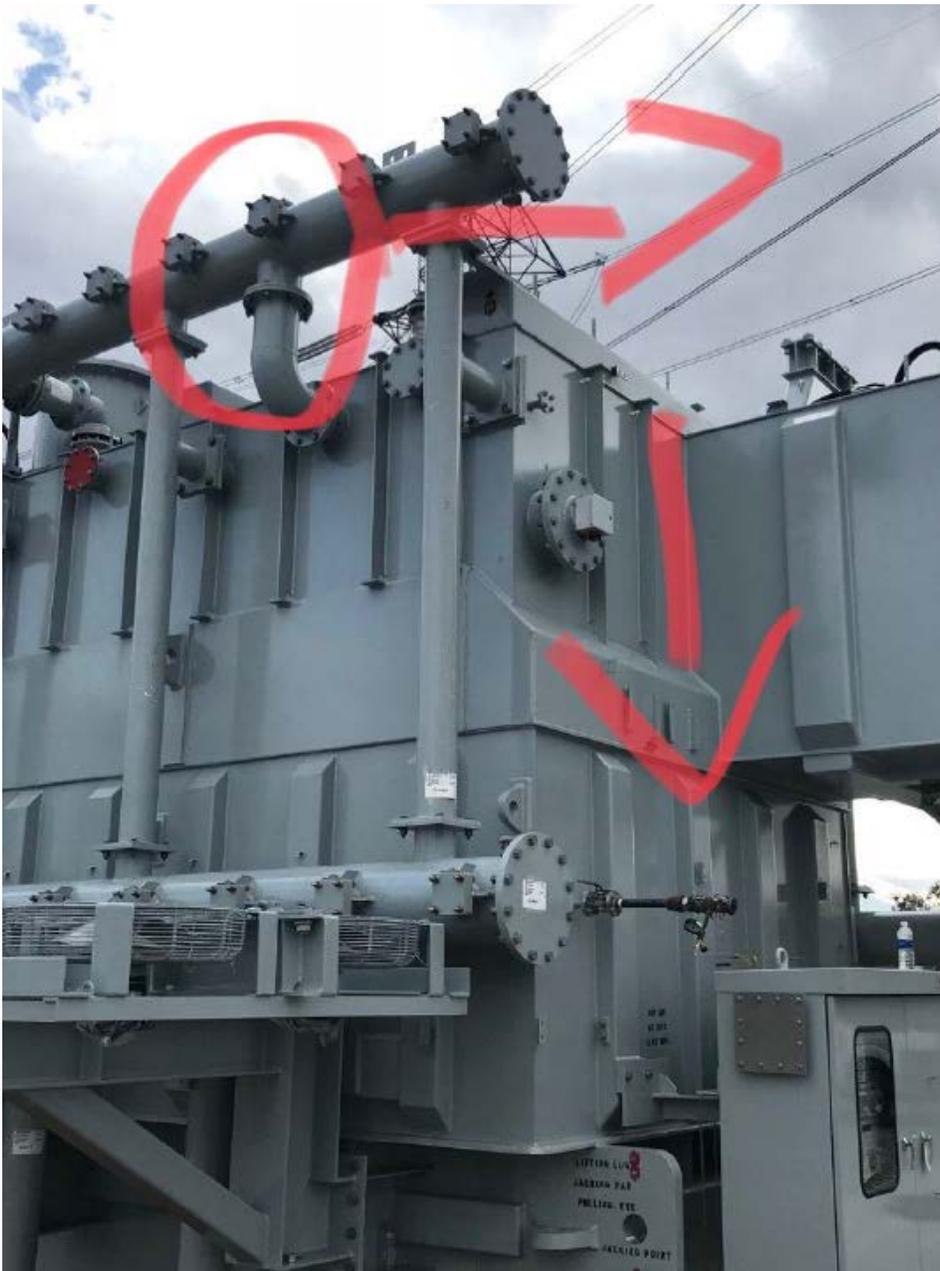
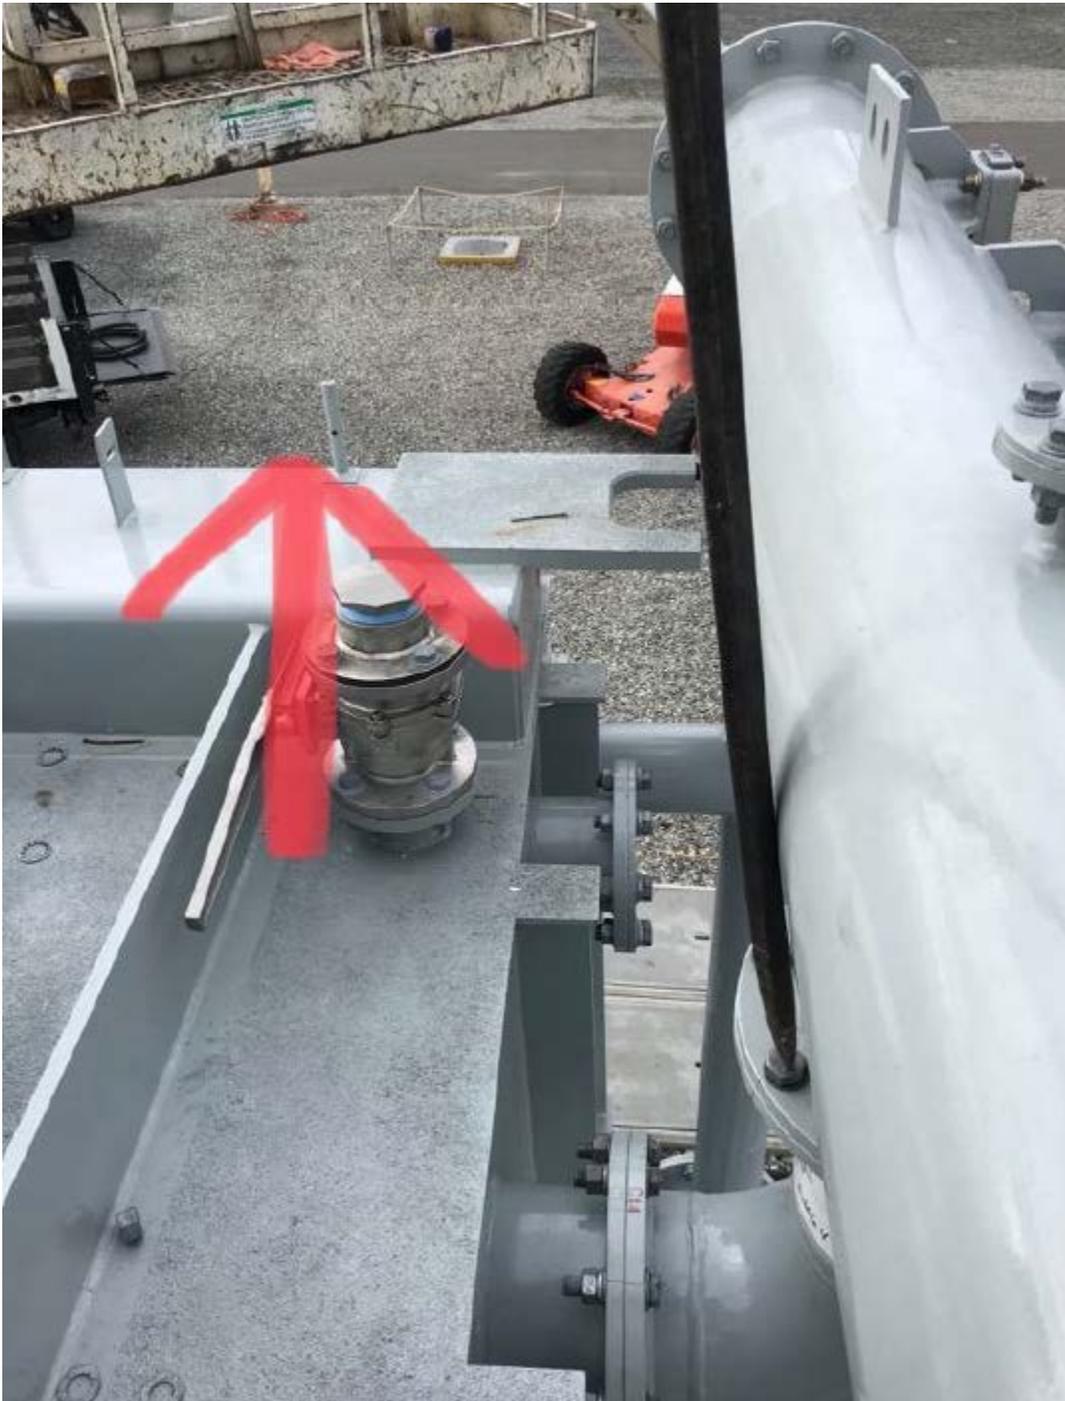
Photos from Incident

An employee was seriously injured when he fell approximately 16 feet from the top of a transformer. The employee was attempting to align a manifold elbow flange when he lost his balance and fell to the ground. Though the injured employee was wearing a fall protection harness and lanyard, it was not attached to the transformer when the incident occurred.

The employee lost his balance when the tool he was using slipped out of a flange bolt hole while significant lateral force was being applied. The length, diameter, and taper of the tool in combination with the bolt hole diameter resulted in the tool being susceptible to slipping out of the hole when lateral force was applied due to insufficient pressure in the flange.

1. Work practices and expectations established to ensure fall protection lanyards are attached and formal peer check is used (3-way communication) by personnel working on top of transformers.
2. Conducted a formal job hazard analysis for working on top of transformers.
3. Identified and procured suitable tool for aligning flanges associated with transformer auxiliary systems.
