NATF Redacted Operating Experience Report

Truck Fell Off Lift Incident

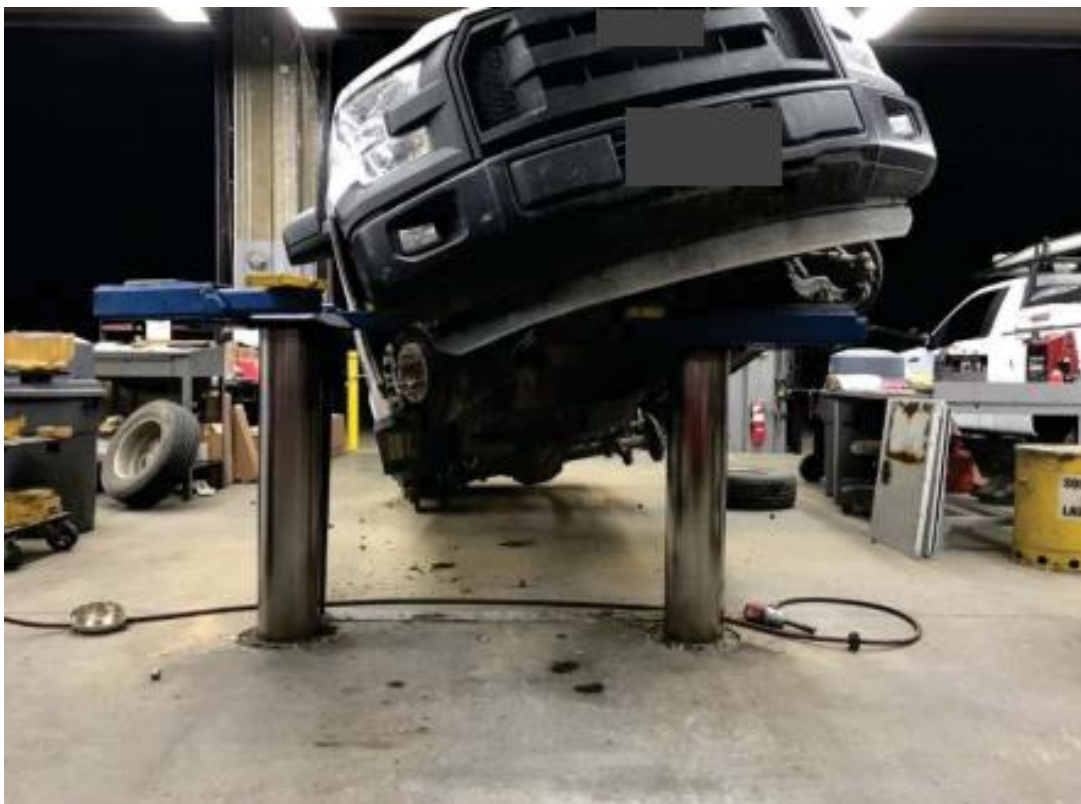
A truck fell off a two-post in-ground lift after having been raised approximately four feet. The truck was damaged, but no employees were injured. The task involved lifting the truck to remove the rear tires, transferring the front tires to the rear, and replacing the front tires.

After the truck was driven onto the lift, the two-post lift arms, which were under the truck frame (with cleats in the opposite direction), were raised in the air. The technician did not notice anything out of the ordinary and removed the two rear tires. The technician then removed the driver's side front tire. When the technician took off the passenger side tire, the truck slid off the lift, resulting in the bed of the truck hitting the ground. The vehicle was supported by the two-post lift in the front, which was at the same height prior to the incident.

After image: truck and two-post lift

1. Ensuring employees are proficient on the vehicle-lift operation before performing work.
2. Ensuring vehicles are lifted at the vehicle manufacturer's recommended lift points.
3. Checking for weight distribution for any potential impact on the center of gravity prior to lifting.
4. Once the vehicle tires clear the floor, shaking vehicle moderately at front or rear bumper to ensure the vehicle is stable.
5. Using jack stands whenever removing vehicle parts or standing under the vehicle.

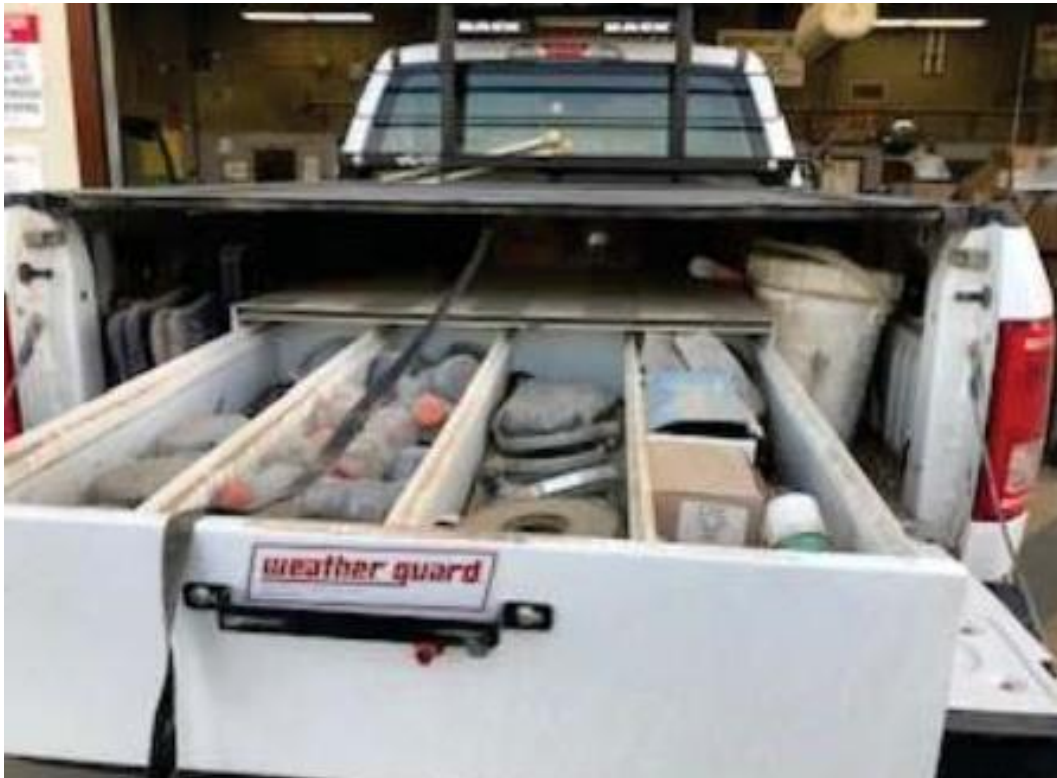
The lift was subsequently placed out of service. Following the incident, the technician noted a heavy grey bin in the truck bed. (The technician did not check the bed prior to lifting the truck.)

Material in bed of truck
