# NATF Redacted Operating Experience Report

## Oil Spilled While Dismantling a 230 kV Transformer

Oil Spilled While Dismantling a 230 kV Transformer

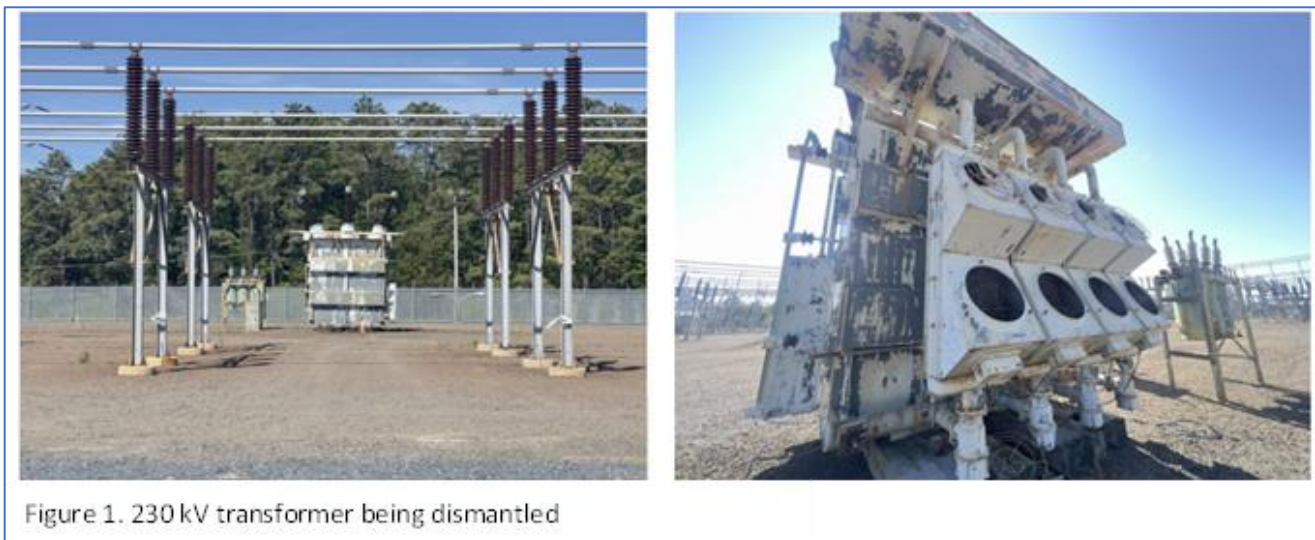
Prior to dismantling a 230 kV transformer at a transmission substation (figure 1), the maintenance crew reviewed the inspection report and hazard assessment plans. The reports stated the transformer had been drained and was ready to be dismantled. As part of the dismantlement process, the crew drilled a hole approximately three feet from the bottom of the transformer, and oil spilled out, getting on several crew members. In response, the crew plugged the hole and reported the incident. The spill was cleaned up.

- The 230 kV transformer was not drained of oil as reported.
- The crew dismantling the transformer was given incorrect information on the inspection report.
- The crew failed to physically check the transformer to verify it was drained.

1. The importance of always double-checking information about the purging of vessels/transformers was reiterated and stressed with construction/maintenance crews.
2. Crews were retrained on performing initial transformer assessments.
