# NATF Redacted Operating Experience Report

Outage Caused by Uplift on Structure After Pole Replacement

(Redacted NATF OER-913)

January 3, 2025

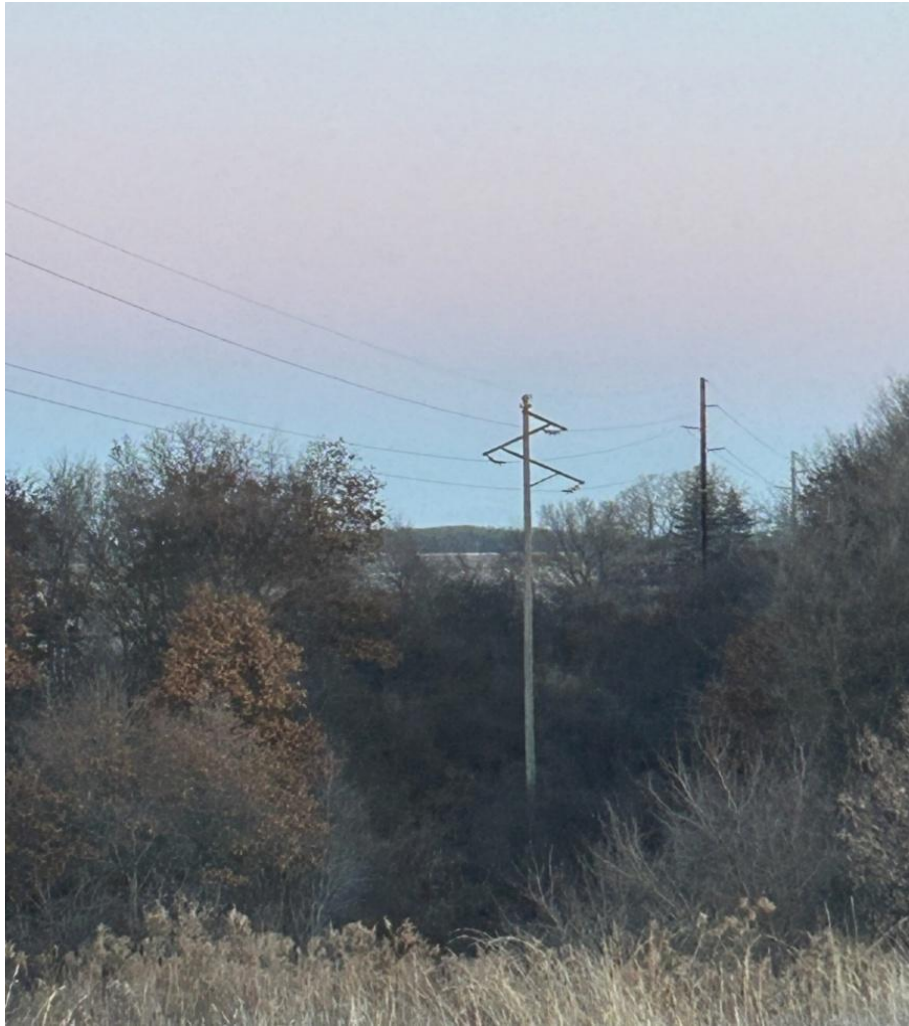
The original pole was a 50-foot class 3 pole with wishbone construction (figure 1). The pole installed in November 2018 is a 60-foot class 1 pole with gain base insulators, which is according to the TO's new standard. This construction configuration follows the TO's standard for replacing wood poles, which includes adding 10 feet to the pole length and going up at least one pole class for wishbone structure replacement.

On January 3, 2025, line loading and cold ambient temperatures allowed the conductor to tighten to a point where the suspension bells on the wishbone configuration uplifted close to the pole static ground, causing the line to trip and lock out. To correct the situation, the line section was left out of service until the TO's contractor could find the right equipment to access structure 95. The crew then changed the wishbone construction to a vertical gain base construction (figure 2). Changing the construction configuration temporarily corrected the uplift issue, permitting the line to be reenergized until permanent repairs to structure 95 were completed.

Figure 1. Wishbone line construction

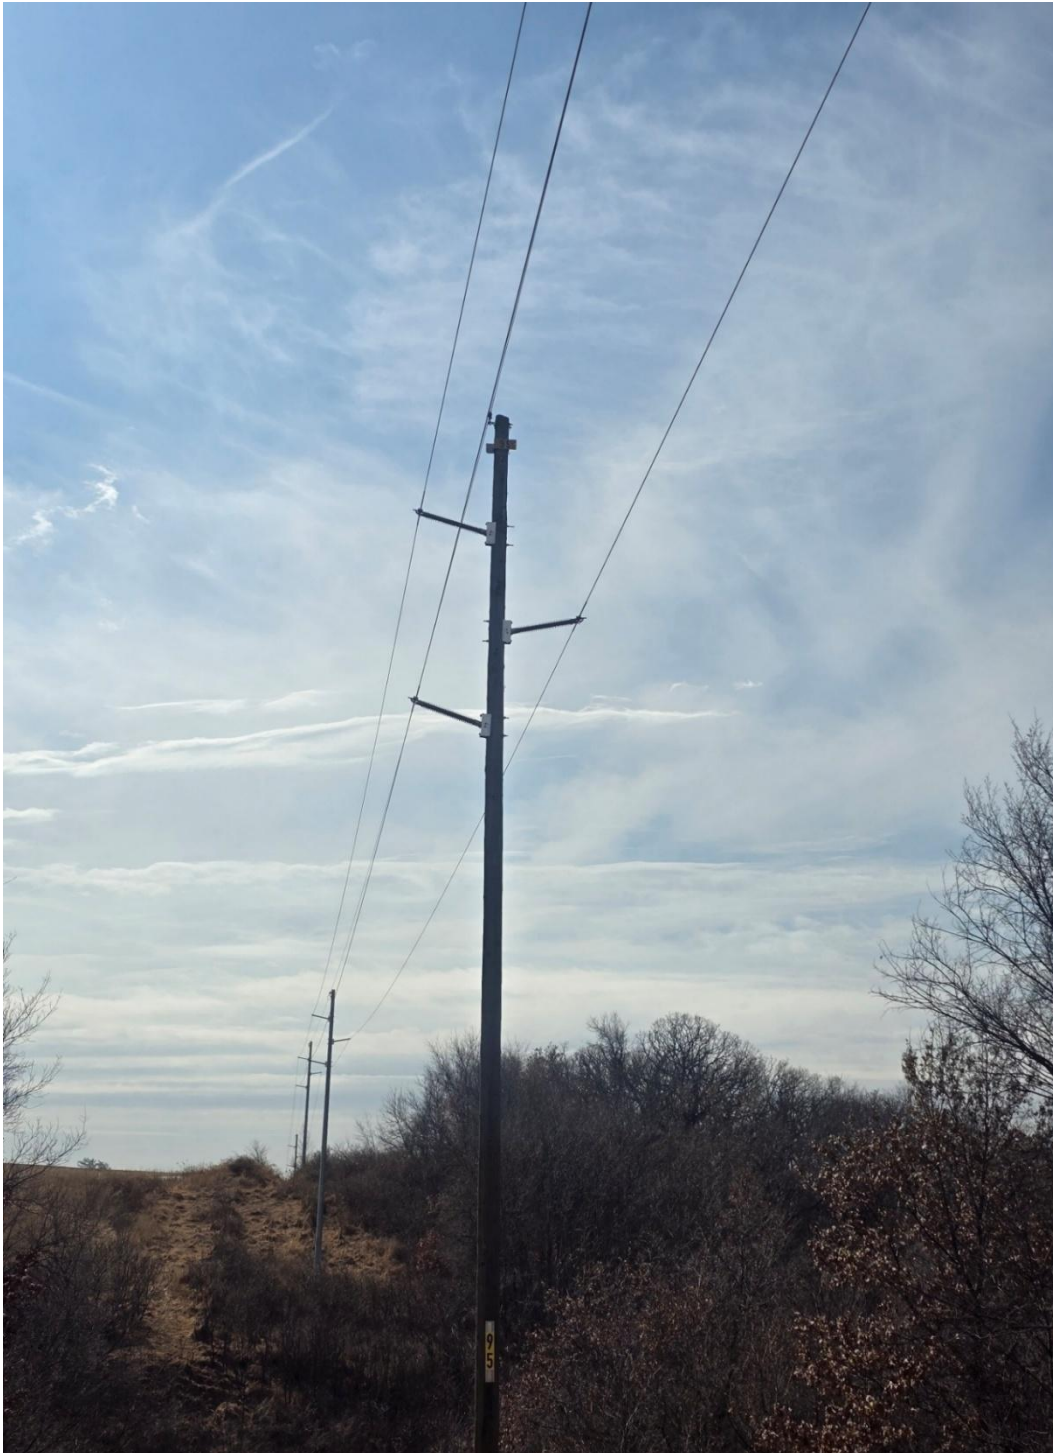
Figure 2. Vertical gain base construction
