NATF Redacted Operating Experience Report

Braided Rope Failure Incident

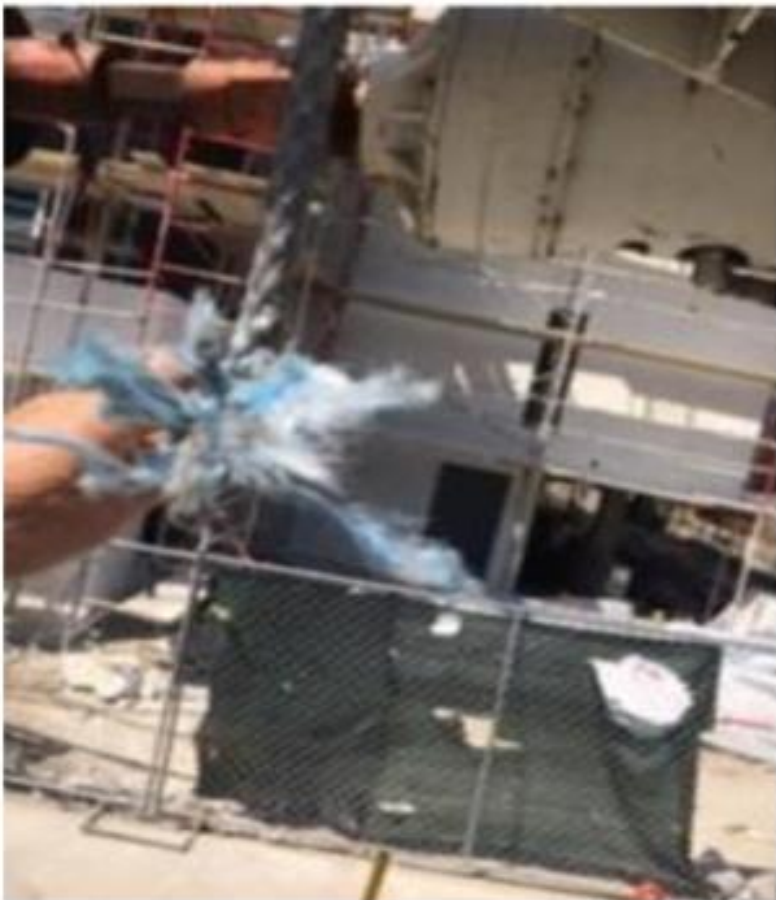
A two-person crew was utilizing a vehicle boom to place a 3-phase pad-mounted transformer when the braided rope suddenly broke. The transformer fell into the front fender of the vehicle and hit the ground. The transformer weighed 6,100 lbs. and was within the lifting capabilities of the boom. The rope's rated capacity was 16,340 lbs.

Figure 1: Rope Failure

1. The braided rope had been in service for 8.5 years prior to the incident due to passing all inspections. The manufacturer does not have an age recommendation, only inspection criteria. Our company will continue to use the manufacturer inspection criteria but now include an age cap for these ropes (4 years).

2. The crew performed a pre-trip inspection of the vehicle, boom, and braided rope. During the pre-trip inspection a visual inspection of the rope is performed. Per interviews, field personnel mostly check for cuts and gross abrasions to the rope. Field personnel had not been provided standardized/written user inspection criteria for braided ropes that detail conditions for which a rope would be retired.
3. Rope-replacement cost is minimal.
4. Daily boom inspections should include a check of braided rope condition, including abrasion.
5. Personnel should not be in the proximity of a suspended load.
6. Should ensure slack in the braided rope is prevented, by maintaining load-line tension, as slack can cause cutting or weakening of the line.

1. Establishing a program to replace vehicle braided ropes at four-year intervals, regardless of rope condition.
2. Developing work methods and an operating bulletin to be placed in vehicles for use in daily vehicle boom check. Operating bulletin will include (1) a written user inspection criteria for retirement of braided ropes based on abrasion and (2) proper work-practices discussion, including practices that prevent cutting or weakening of the ropes (i.e., load line tension always required) and operating the boom only within the load chart.
