NATF Redacted Operating Experience Report

Bucket Truck Leveling Malfunction

Reference: NATF-OER-627

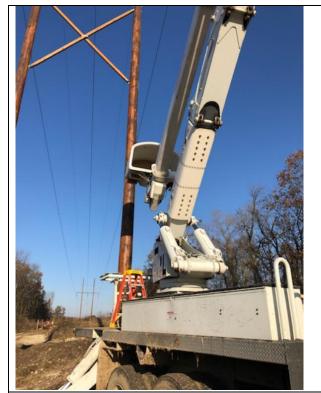
A contractor crew was framing a pole when a circuit deenergized. Work was underway, 100-feet aloft, using a rented bucket truck. This truck model is designed to automatically self-level. A lineman was in the bucket at the static location when the bucket began to tilt backward. The lineman stopped to make sure nothing was pushing the controls (e.g., tools, materials, etc.) and determined there was nothing touching the controls. The lineman started to boom down, and the bucket tilted even more.

View of bucket tilt.

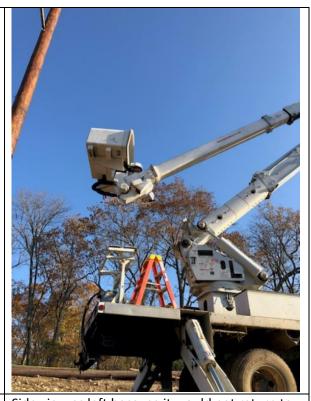
The bucket would not return to the stowed position. The lineman exited the bucket using a ladder to descend to the ground. It was determined that this truck was not part of any manufacturer recall. The rental company is investigating maintenance and inspection records and working with the manufacturer to determine the root cause of the mechanical failure. There were no injuries or equipment damage.

Side view as left because it would not return to stowed position.

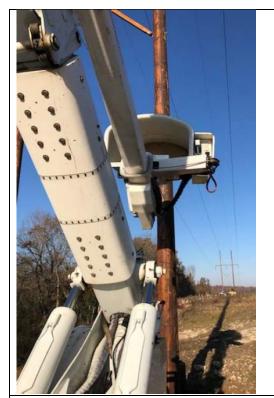
View from front toward rear, showing the jib line.

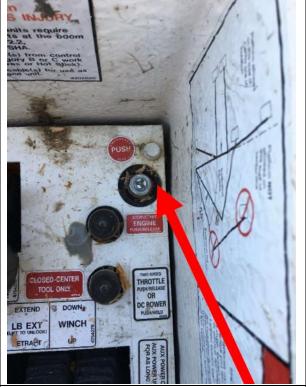
- 1. Always wear fall protection while in the bucket. Had this crew member lost their grip, the properly worn and secured fall protection would have prevented a tragic outcome.
- 2. Proper training on bucket rescue resulted in proper performance of the recovery task and prevented further issues or injuries with the apprentice's prompt rescue response.
- 3. Proper emergency response should be exercised in non-emergency situations to ensure that proper response becomes second nature. The lineman in the bucket was too startled in the heat of the moment to try the emergency stop control.

Bucket controls, with arrow pointing toward the emergency stop button.
