NATF Redacted Operating Experience Report

Bucket Truck Rollover

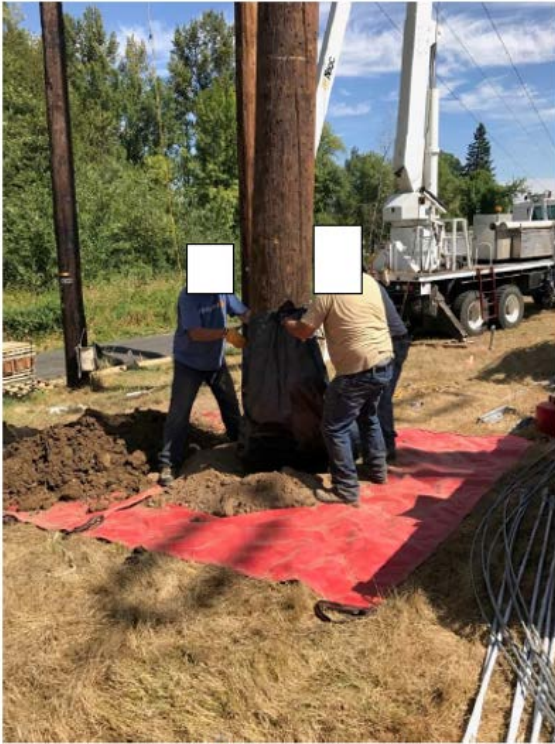
At 13:18, TLM crew 2 setting poles

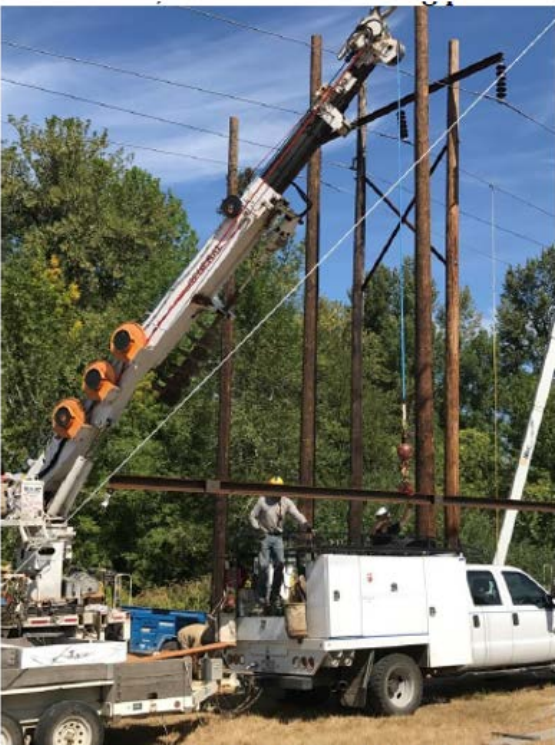
At 13:32, TLM crew 2 installing crossarm

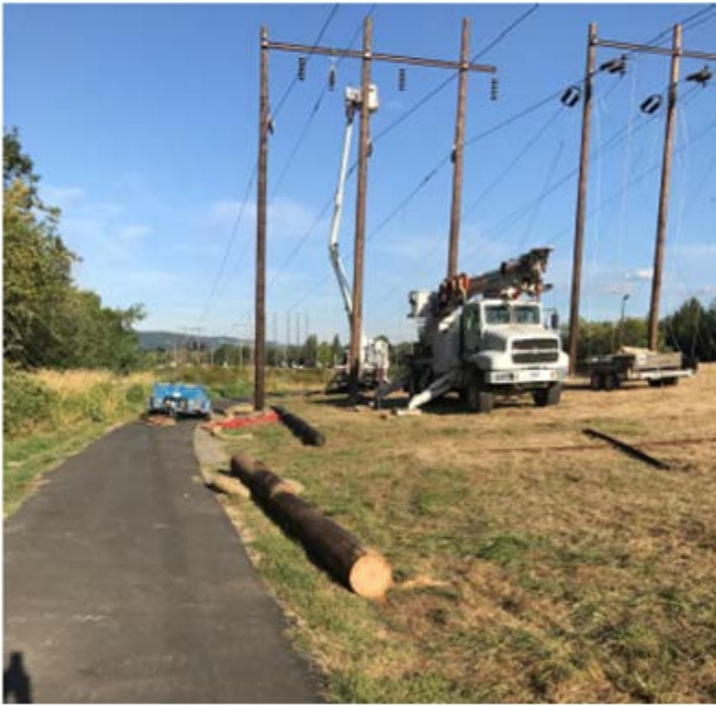
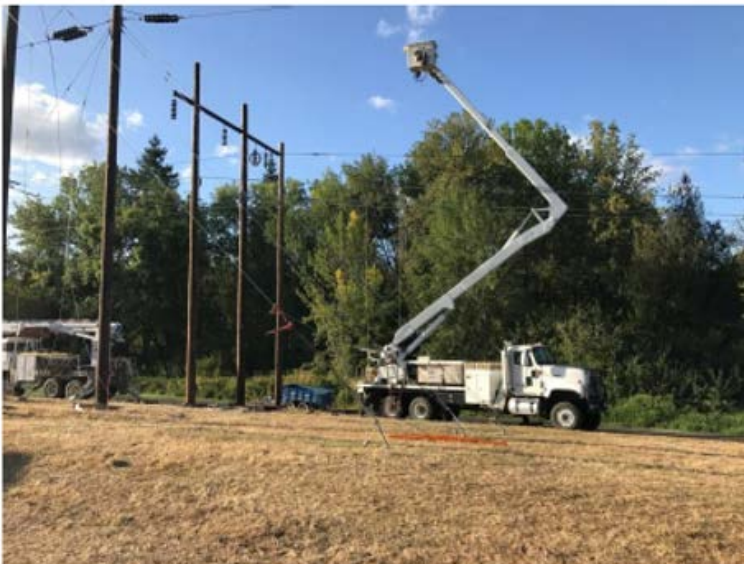
At 18:16, the stored boom between conductors is greater than 50-feet above ground for tool theft protection. Note that truck is set on a double slope, with an approximate 5-degree drop from back of truck to front of truck and a 5-degree drop from curb side (passenger side) to street side (driver side).

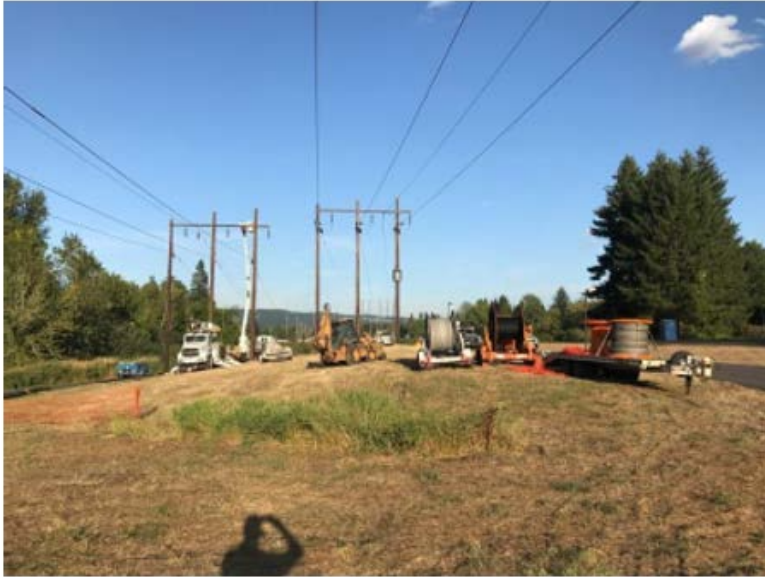
18:23: last known photo of incident site looking to the east

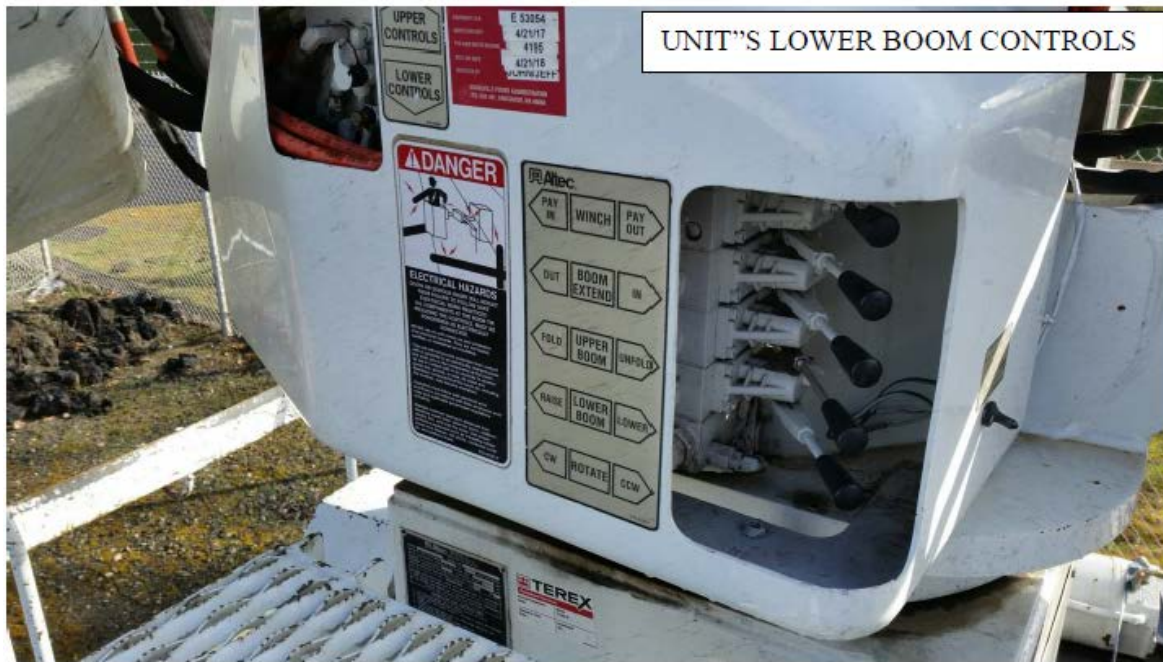
At approximately 19:18, the crew 3 foreman proceeded to the unit's lower controls located on the pedestal of the unit above the truck bed. Before lowering the boom, he realized he did not have the proper PPE and left the controls to retrieve his PPE out of his work truck.

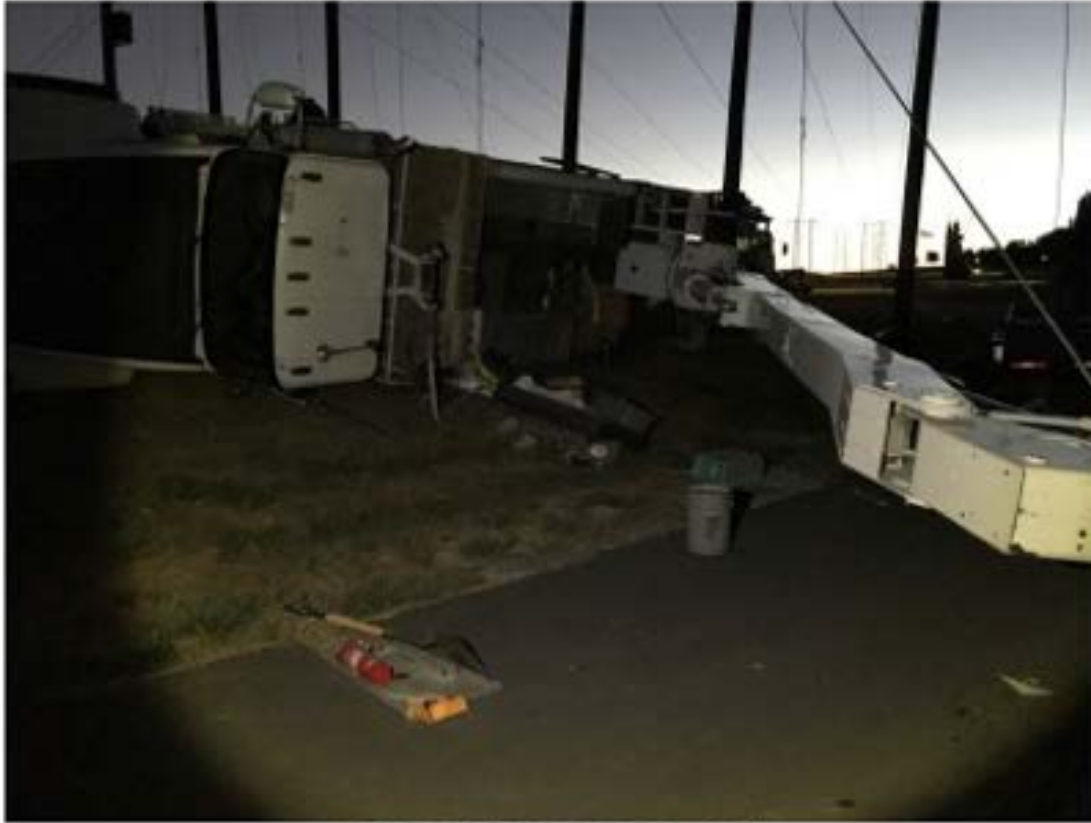
8/30/2017 20:35

At approximately 19:23, the boom descended toward the low side, contacted two conductors and the fiber line, and pinned them toward the ground. The bucket truck came to rest on to the street side (driver side) with the boom falling across a barricaded paved walking trail, with the upper boom and bucket landing in heavy brush.
