# NATF Redacted Operating Experience Report

## Dropped Ram during Structure Jacking

Dropped Ram during Structure Jacking

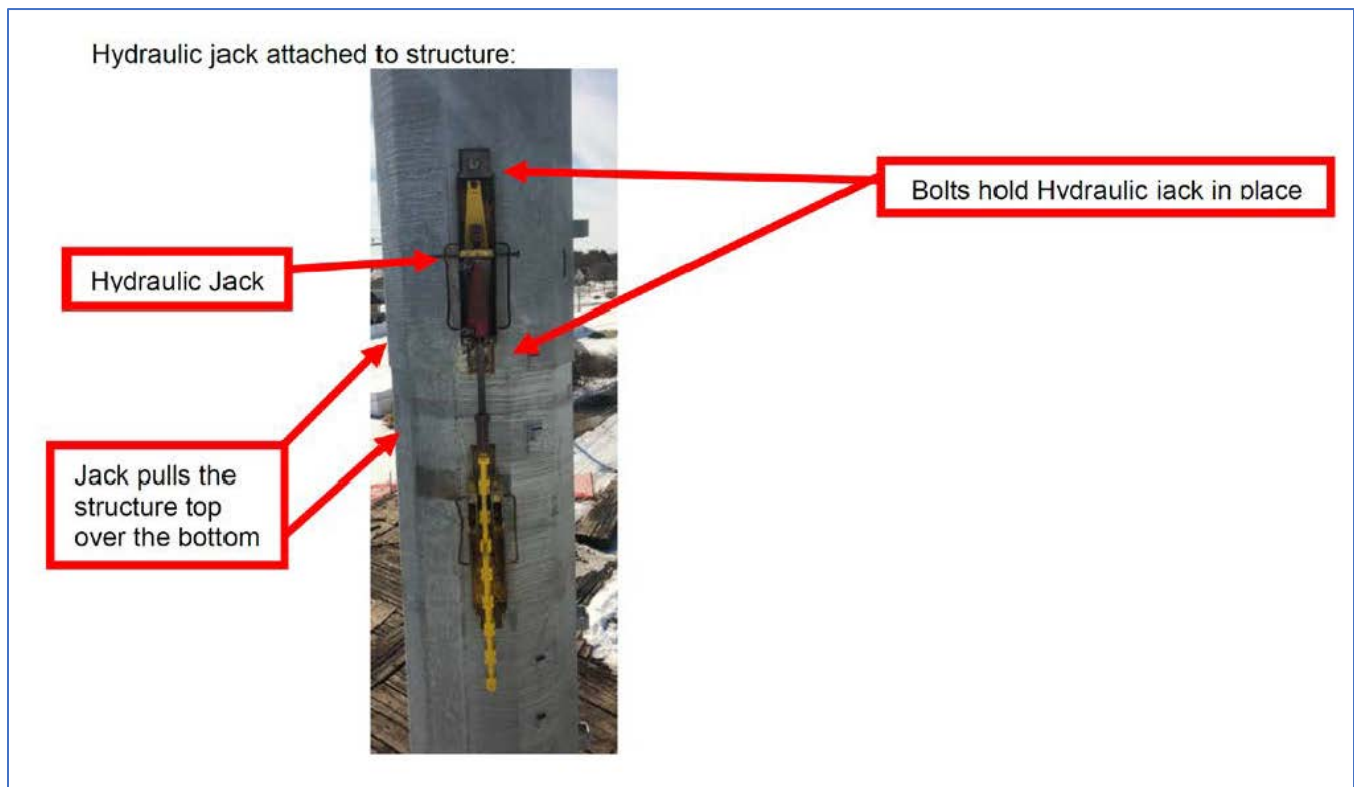
While in the process of using a hydraulic ram to force two transmission tower sections together (jacking), the ram broke loose from the structure and fell 35 feet to the ground. The contractor found the threads stripped out on the 1" X 1" bolts that hold the jacking plate in place and on the nuts that were welded to the structure by the manufacturer.

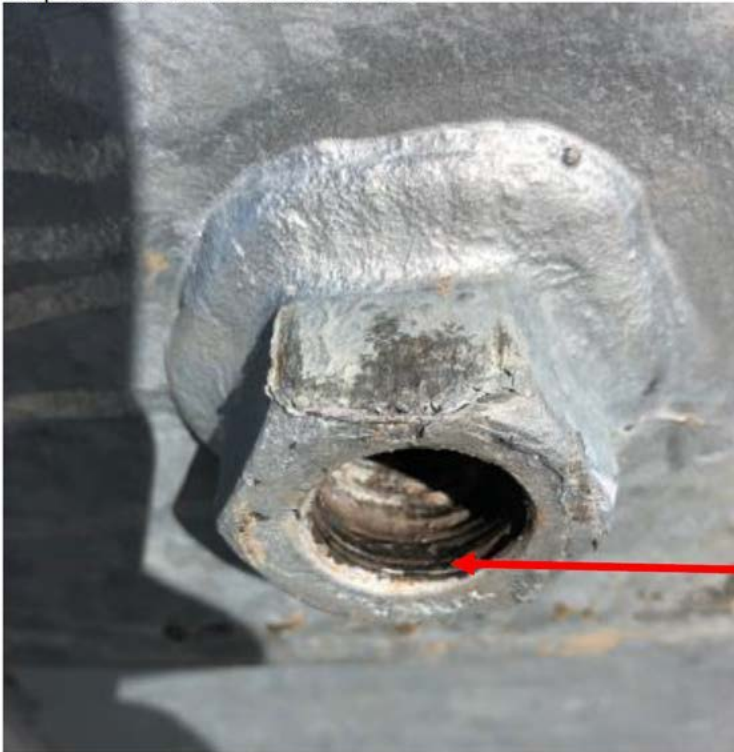
- Possible wear of bolts from multiple previous uses.
- Possible defect of nut welded to structure by manufacturer.
- Improper mounting of jacking plate.

stripped threads

Stripped bolt used to hold hydraulic jack in place

- Reinforced the importance of always reviewing line of fire and drop zone hazards.
- Ensure proper mounting of jacking plate to ensure forces are transferred across the jacking nuts welded to the pole section as expected. Proper mounting includes ensuring welded jacking nuts are properly spaced within the required tolerance. The treads should see minimal forces if the jacking plates are mounted properly.

1. Reminding and encouraging crews to always stay out of fall zone.
2. Replacing jacking bolts in all five jacking kits used by the contractor.
3. Developing lessons learned from this near miss.
4. Procuring thread gauges for jacking bolts.
5. Stocking each jacking kit with a threading gauge to allow better inspection of bolts.
6. Developing bolt-changeout requirement.
7. Communicated proper mounting of the jacking plates to the pole section.

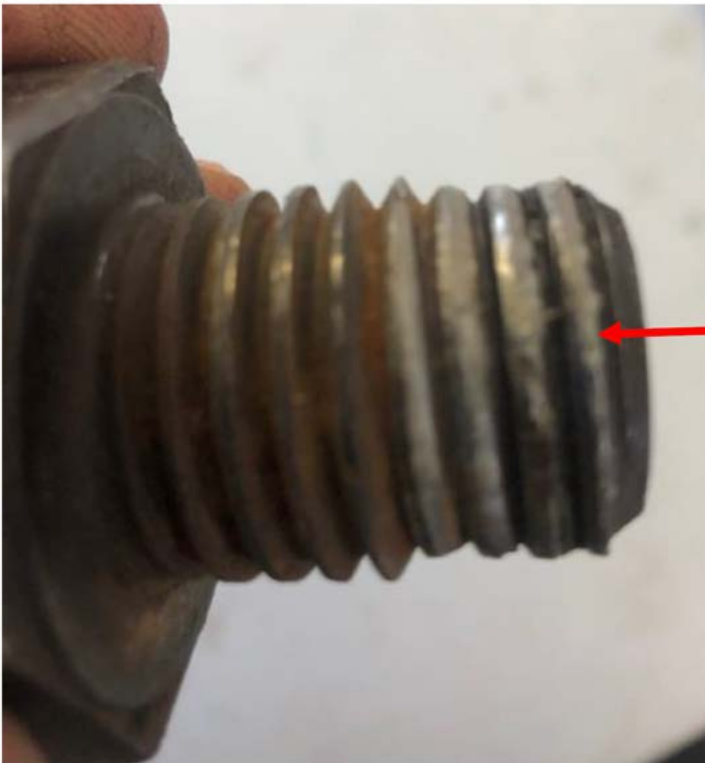
4 stripped threads
