# NATF Redacted Operating Experience Report

## Employee Falls and Sustains Injury

Employee Falls and Sustains Injury

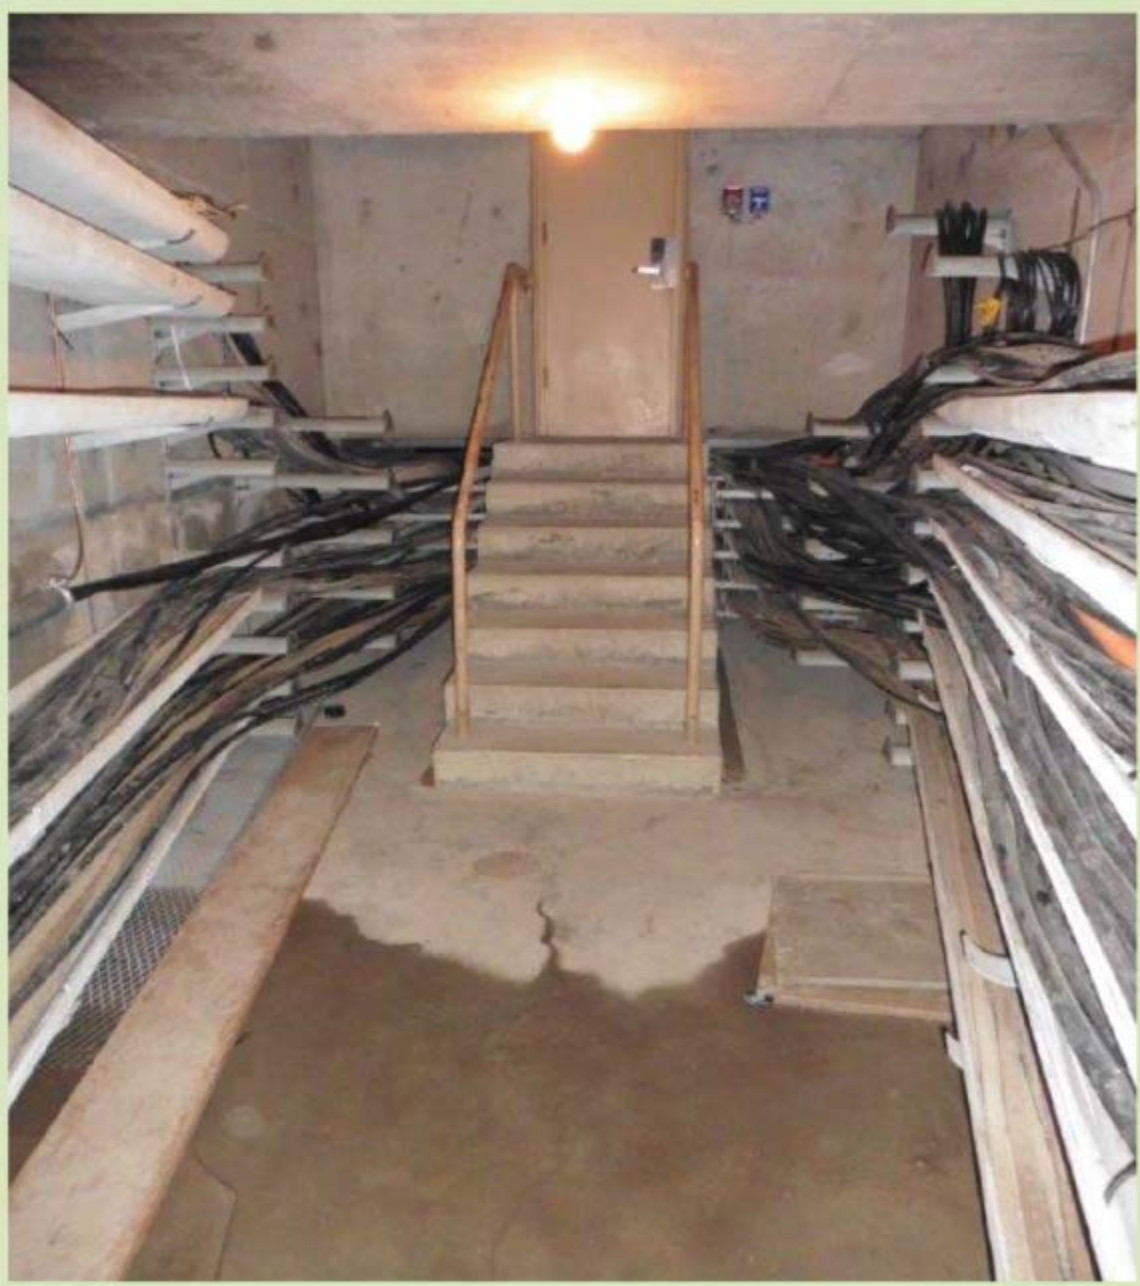
During the fall, the Employee's lower right leg became entrapped between the handrail and a lower concrete stair riser breaking their right lower leg.

1. Address deficiencies in safety critical lighting
2. Update legacy installations
3. Increase communications of hazardous situations
4. Create a maintenance program that identifies and prioritizes safety-critical repairs and upgrades
