NATF Redacted Operating Experience Report

Faulty Safety Rope Discovered During Training

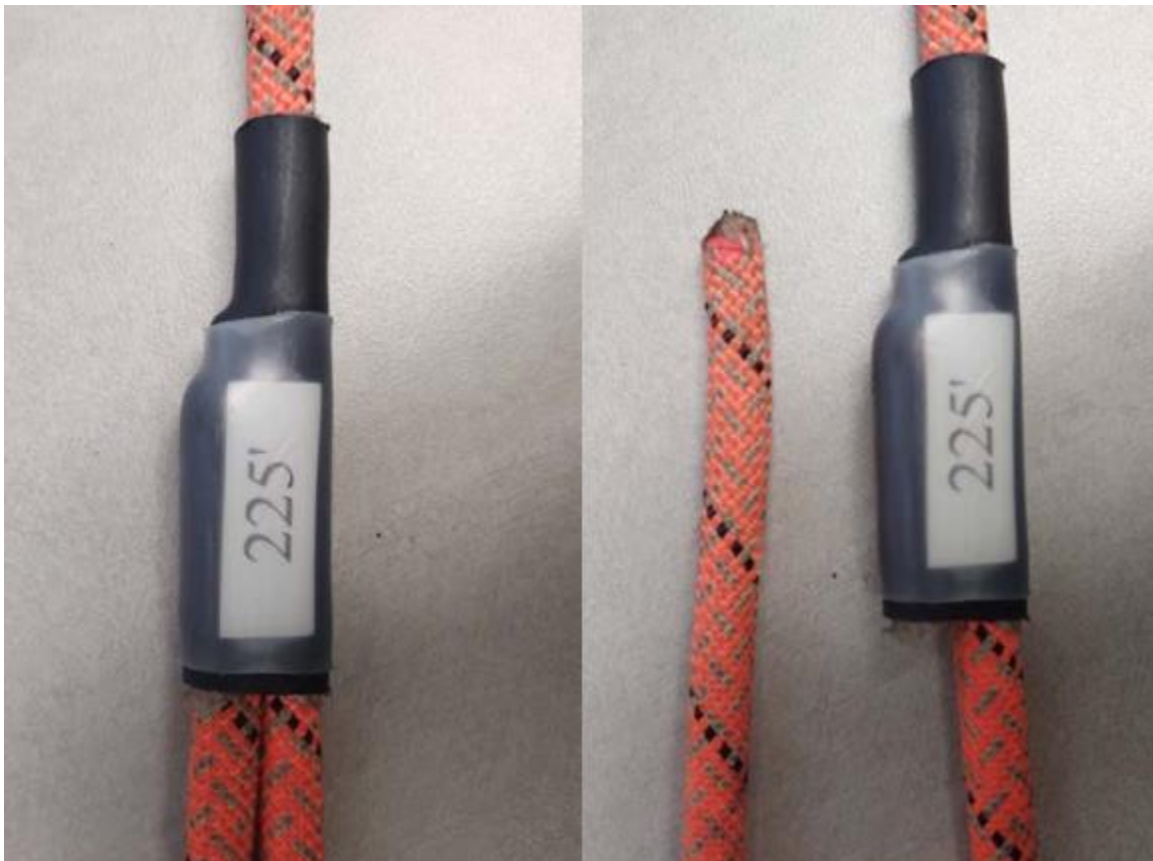
This report pertains to a safety rope that was removed from service due to being modified in-house. The rope, discovered during training, had been modified in such a manner that it gave the appearance of a factory termination. The rope had been cut to a custom length, looped into an eye, and shrink tubed. The rope did not have any stitching and did not have the approved knot to secure the eye. The loop was only held in place by the glue in the shrink tube. This could have resulted in a serious incident.

A safety alert was issued with the expectation that the alert will be reviewed at the next safety meeting and inspections of like equipment will be performed prior to the next use.

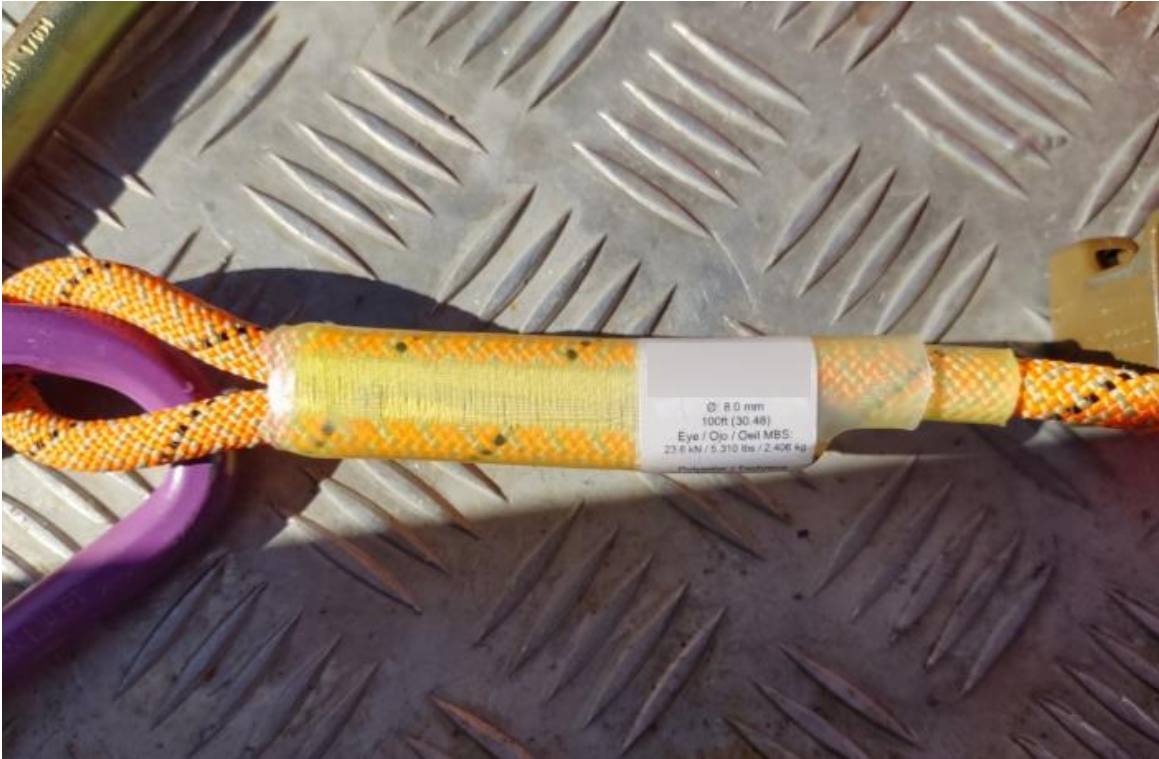
This type of rope comes from the manufacturer with a factory termination as shown in the picture below. The factory termination will always come with a clear shrink tube to allow for inspection of the termination stitching. In addition, the tag placed under the shrink tube contains the manufacture date, size, length, strength, and lot number.
