NATF Redacted Operating Experience Report

Lineman Fall Incident

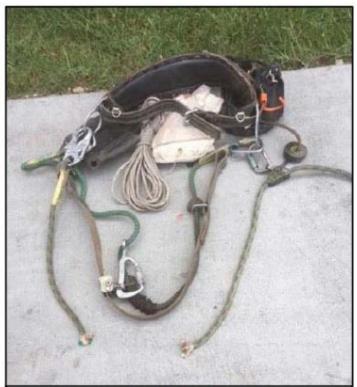
Two crews were tasked with installing a primary riser, pulling in primary and secondary cable from a pad-mount to a panel, and then to a pole. An apprentice lineman was using a primary climbing belt/harness and rope secondary safety (see photo below), which is an approved combination for pole climbing. The apprentice lineman was transitioning above the communication lines in order to "ream out" an existing hole when a second apprentice lineman reminded him to install the unistrut brackets. The apprentice lineman had the secondary rope safety engaged; however, he did not re-engage his fall-restriction equipment. The rope safety was across the hole on the backside of the pole. When the drill bit reached the end of the hole, it severed the rope safety.

The apprentice lineman subsequently fell off the pole at the communication level, approximately 10 to 15 feet, before hitting a roof and then falling an additional 6 to 8 feet to the ground. The electrical crew foreman assessed the employee for injuries. The employee stated he was okay and did not want to be transported. The foreman called 911, and the employee was taken to the hospital for further assessment, where he was evaluated and released the same day.

Figure 1: Apprentice Lineman No. 1's Fall Restriction Equipment (FRE). Note the rope safety that broke as a result of being drilled through.

The rope safety is more susceptible to failure in the case of human error when drilling tools are used while on a pole.

Transition from the use of rope safeties as an approved secondary safety to the use of belt safeties as an approved secondary safety.

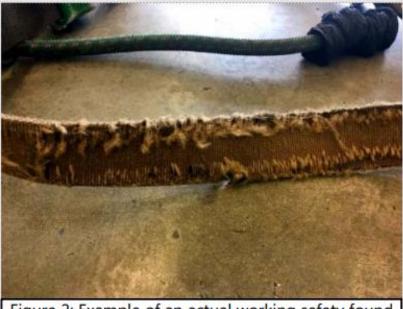
Figure 2: Example of an actual working safety found in the field.
