NATF Redacted Operating Experience Report

Pole Splicing Rigging Plates

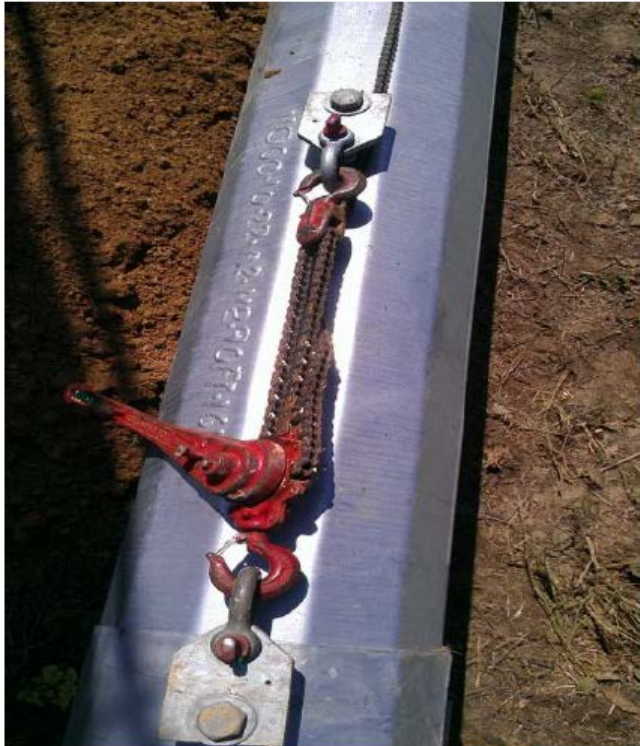
1. The use of the bent pole-splice rigging plate created leverage and unintended direction of force on the bolt and nut attachment point.
2. The affected bolt was not fully engaged based on load cell tests.
3. The affected pole-splice rigging plate had been damaged from other activities, which caused unnoticeable damage to the plate.
4. Based on replication of failure, a combination of contributing factors #1 & #2 lowered the SWL (safe working load) near the tension supplied by the 3-ton chain hoist.

Old Plate - load transferred through bolt treads to welded nut

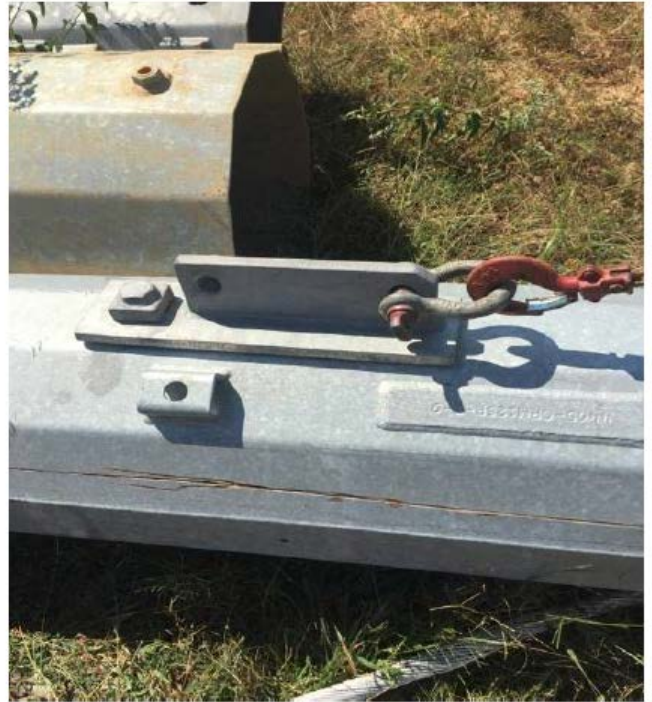
New Plate - load transferred to surface of nut

- Pole-splice rigging plate assembly involved in the incident immediately removed from service.
- Notification to cease using this device was communicated across all line construction crews.
- Three hydraulic pole jacking devices were procured as an interim corrective action.
- New plates were designed to transfer load to surface of welded nut on pole instead of transferring load through threads of nut.
