NATF Redacted Operating Experience Report

Regulator Not Placed in Neutral Position Prior to Bypassing

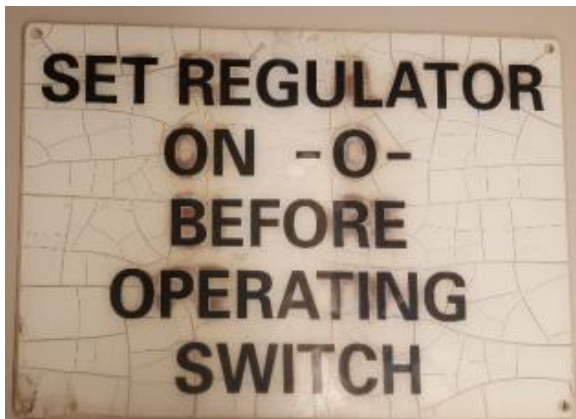
While bypassing a regulator, a switchman forgot a step specified in a procedure (i.e., to place the regulator in the neutral or “0” position).

Distribution switching conducted by the crew does not regularly bypass the regulator, and the scope of work changed the morning of this event. The scope of work was appropriately changed when it was suggested to bypass the regulator because it is a much safer practice before changing out the controllers. Once the switch was operated, an internal fault in the regulator occurred and the equipment was damaged. This incident caused a 20-minute outage to a customer. This event, however, also serves as a safety near miss. Any improper bypassing operation could have resulted in an explosion and/or fire, which could have resulted in a serious injury or death.

1. Where appropriate, the company installed better signage for warning switchmen of ensuring the regulator is in the neutral or “0” position before operating the switch.

2. Training was conducted with maintenance personnel on metering and bypassing regulators.
3. The procedure used for distribution switching will be revised to include more detailed language for bypassing regulators.
