NATF Redacted Operating Experience Report

Worker Injured by Fall While Accessing Bucket on Truck

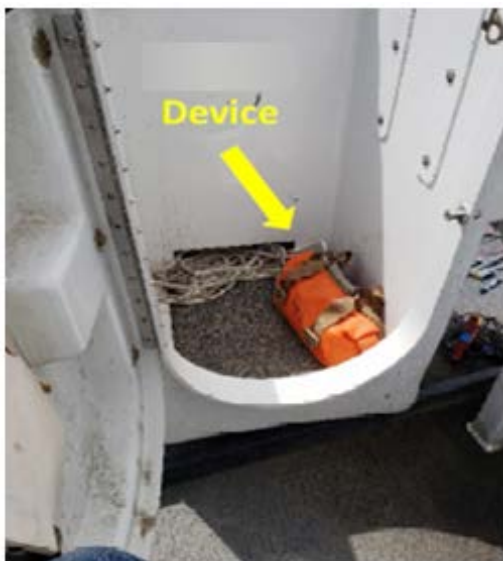
J1 stepped into the bucket from the rear of the truck and pulled the door closed behind him. The primary latch on the door most likely failed to fully engage when the door was closed due to it being in a degraded condition. J1 did not ensure the door-latching mechanism was engaged or attempt to engage the spring-loaded thumb latch as he was accessing the bucket at that time and was not yet prepared to raise the bucket off its cradle. As J1 positioned within the bucket to attach his lanyard to the tie-off ring on the boom, J1's foot contacted one or more items lying loose on the floor of the bucket (e.g., a descent device, rope, brackets, fasteners), causing J1 to lose balance. J1's back contacted the unlatched bucket door, which then opened outward per design, resulting in falling backwards onto the truck bed. J1's back and the left side of his body impacted an unsecured spare tire lying on the truck bed with sufficient force to induce multiple injuries.

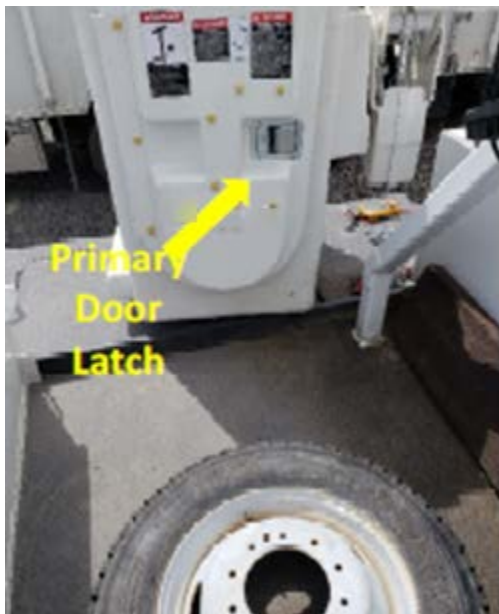
**Approximate location of
Spare tire on truck.**

1. Removal of hazard (rescue devices will now be stored in a container external to the bucket, versus in the bucket posing a tripping risk).
2. Develop a procedure for acceptable (standard) storage practices.
3. Create red-tag policy for equipment, training on process, and checklist for equipment usage.
4. Develop load securement program for all motor vehicles.
