# NATF Redacted Operating Experience Report

## Fall from Pole Incident

Fall from Pole Incident

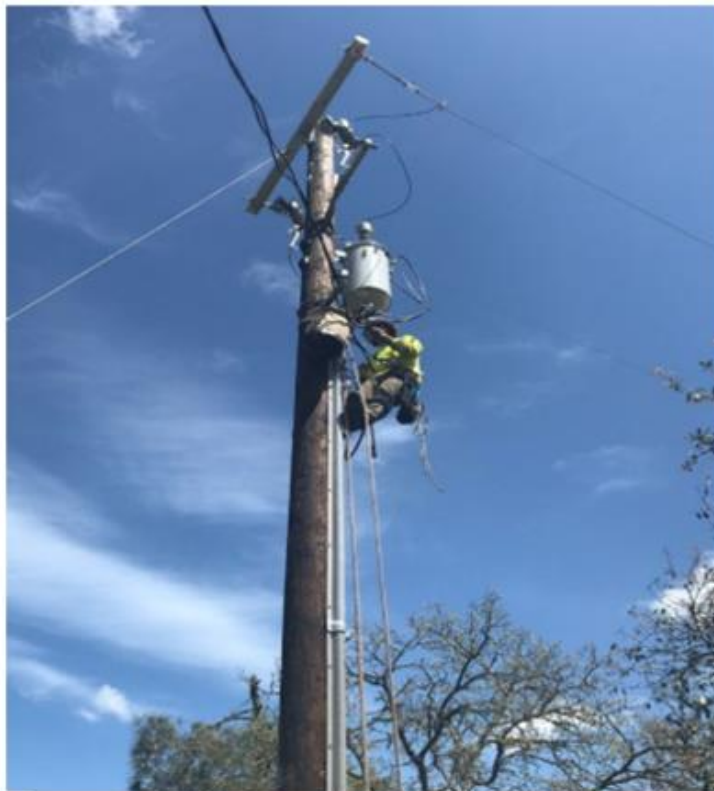
As part of new transformer installation work, an electric distribution contractor apprentice and journeyman lineman climbed a pole to make the secondary connections. The work area was approximately 25' from the ground (figure 1). The apprentice positioned himself under the transformer and had the secondary conductor laying across his belt over the braided synthetic rope portion of his safety line (figure 2). The apprentice began to cut the secondary conductor to length using lopper-style cutters (figure 3). While cutting the conductor, the apprentice inadvertently cut through the majority of his braided safety line (figure 4). The safety line then snapped, causing the fall-restraint equipment to open, resulting in the apprentice falling approximately 25' to the ground.

*Figure 1. Simulated location of employee*

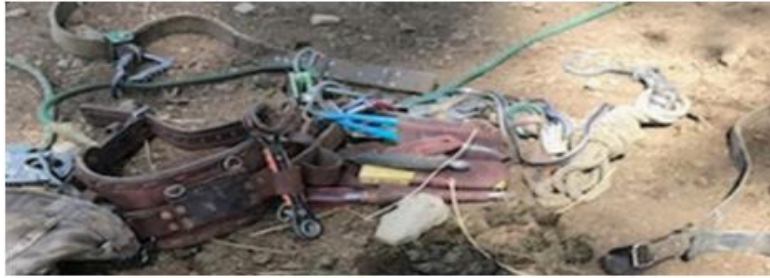
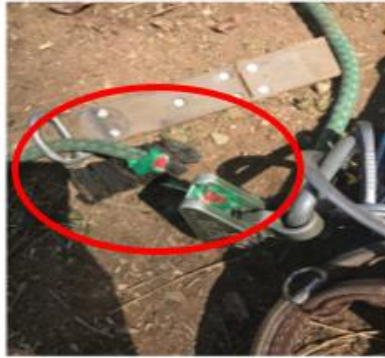
*Figure 2. Pictures of safety belt configuration with cut braided safety line*

1. Fall protection and personal protective equipment were properly used until the braided safety line was compromised.
2. When using loppers for cutting, ensure the blades are clear of any object (e.g., safety lines, body parts, etc.) other than the object intended for cutting.
3. Maintaining situational awareness is critical when performing work from a belted position.

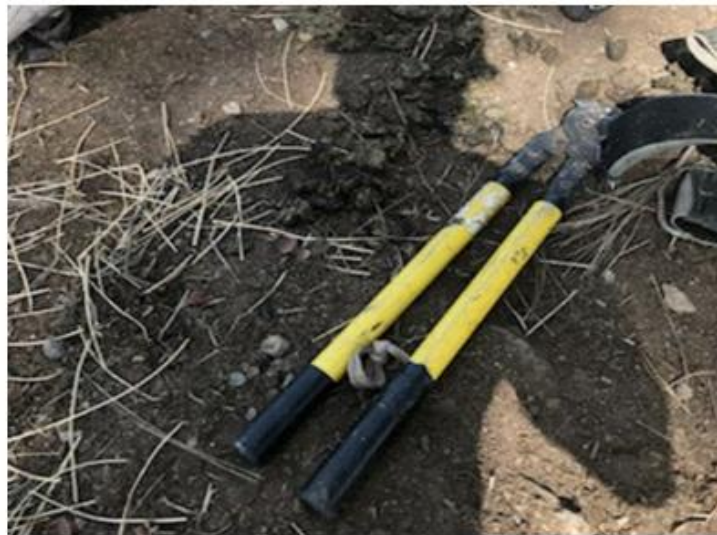
*Figure 3. Lopper style cutters*

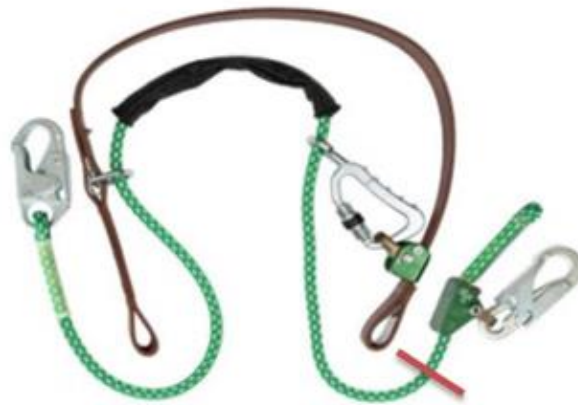
*Figure 4. Braided safety line example indicating approximate cut location*

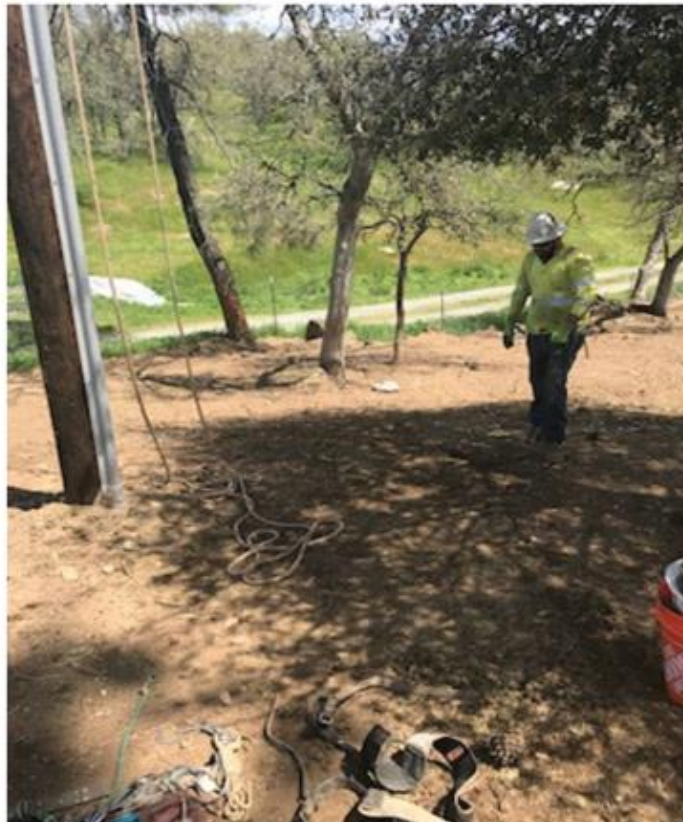
The apprentice fell face down through some small tree branches located next to the pole (figure 5), landing on his right side. Immediately following the fall, crew members rushed to assist. A property owner at the jobsite contacted 911 at the foreman's request, and the apprentice was transported via medevac to a hospital due to concerns of possible head trauma. The apprentice sustained a broken arm and was admitted to the hospital overnight for observation and additional medical treatment.

*Figure 5. Estimated location of impact on packed soil*
