NATF Redacted Operating Experience Report

Safety Incident during the Removal of 230 kV Bushing

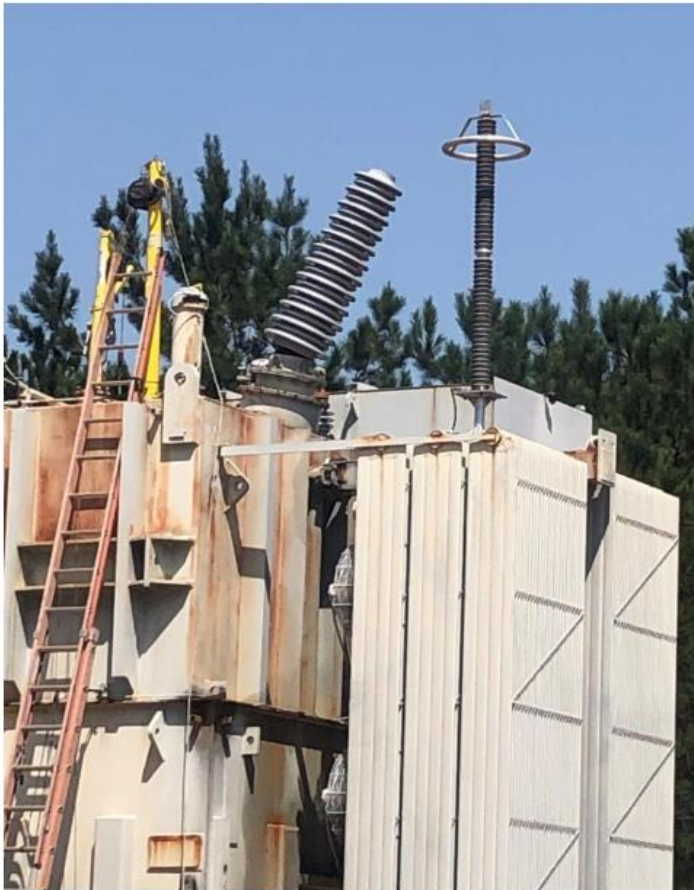
A contract employee was working to remove the bottom connections of a failed 230 kV bushing inside a 500/230 kV single-phase autotransformer. As he began to loosen the bolts on the bottom tap of the bushing, the rod slid out of the bushing housing and dropped approximately four feet, striking the top of the winding. The contract employee was positioned such that he was out of the line of fire.

Insulator part of the bushing being supported by the bushing rod after it had fallen

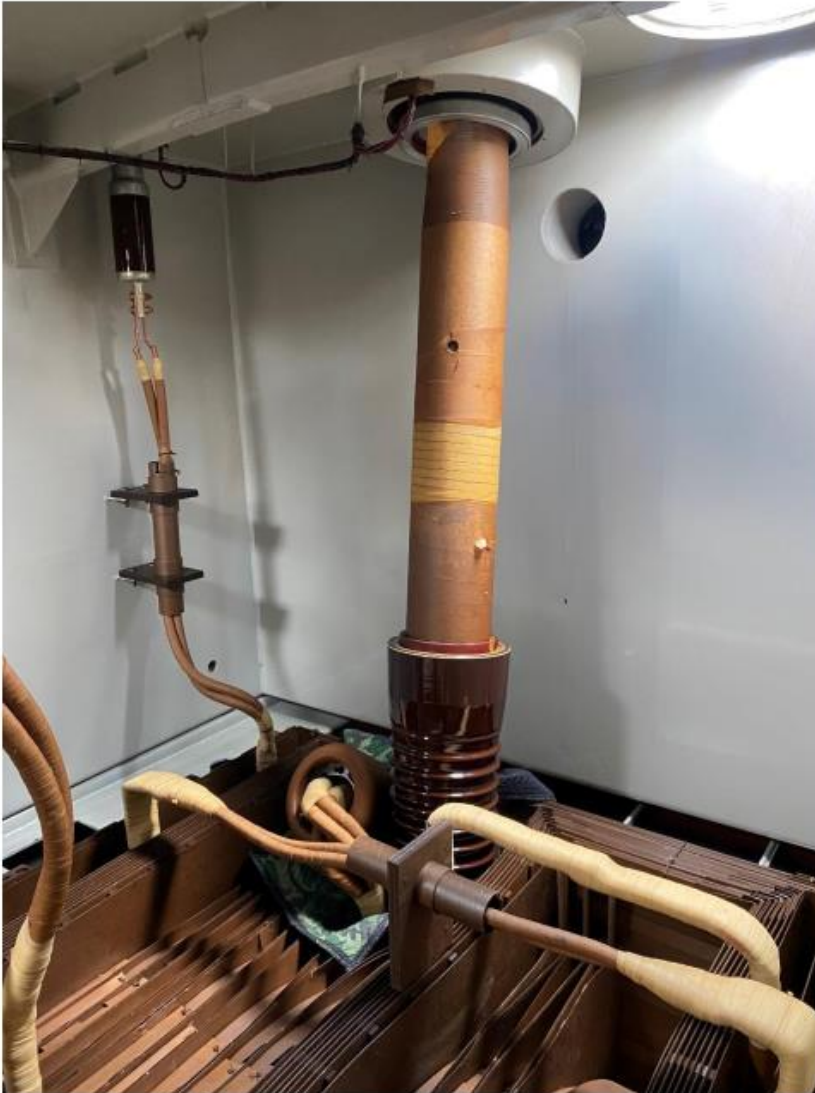
View inside tank of fallen lower bushing.
