# NATF Redacted Operating Experience Report

## Transmission Line Trip Due to Grounds Left in Place

A 230 kV transmission line tripped following a reconductoring project due to grounds left in place on a structure.

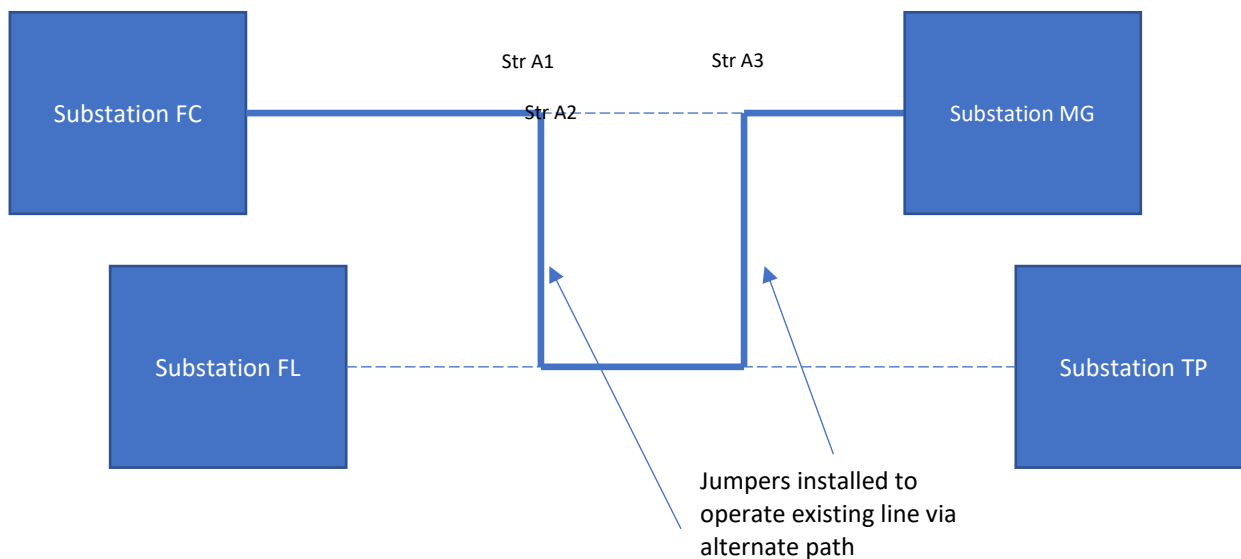
Figure 1: Simplified one-line diagram

A contract transmission line crew was tasked with reconductoring a section of line between structures A1 and A3 on the Substation FC to Substation MG 230 kV line (as shown in figure 1). In the same transmission right-of-way, a 230 kV line was being built between the new Substation FL and the existing Substation TP.

A clearance was requested and issued to allow for the reconductoring. The line section had a temporary jumper from the air-gapped Substation FL to Substation TP line. Temporary protective grounds (TPGs) were placed on the line section to be reconductored at structure A2, and the clearance on the Substation FC to Substation MG line was released to system operations.
