NATF Redacted Operating Experience Report

Safety – Improper Installation of Safety Grounds

Improper Installation of Safety Grounds

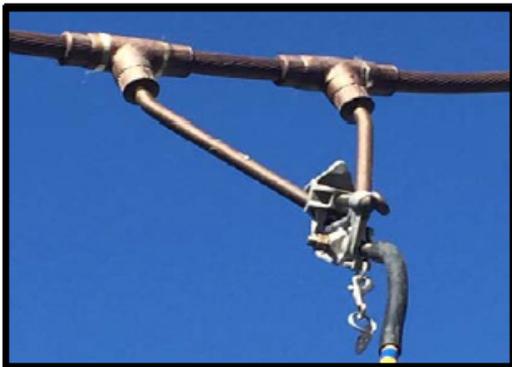
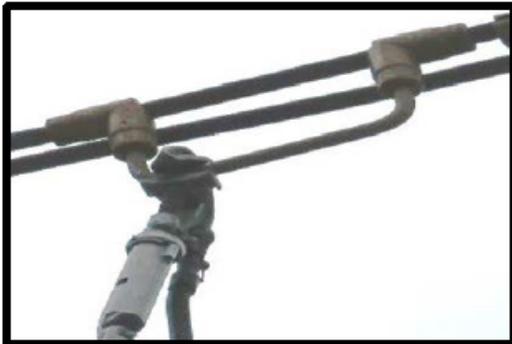
I
N
C
O
R
R
E
C
T

While performing a routine 161 kV circuit breaker test, a crew observed loose safety grounds. The safety grounds were applied near the bend of the grounding stirrups (where the resting weight may cause the safety ground to go during attachment). One corner of the temporary ground clamp was tightened in the bend and not completely flat on the ground stirrup. After slight vibration, the clamp slid out of the bend and became loose.

1. When using grounding stirrups, the temporary safety ground should be attached in the middle of the flat portion of the stirrup and away from any bends.
