NATF Redacted Operating Experience Report

Safety – Caisson Drop Accident

Caisson Drop Accident

Transmission Caisson Drop

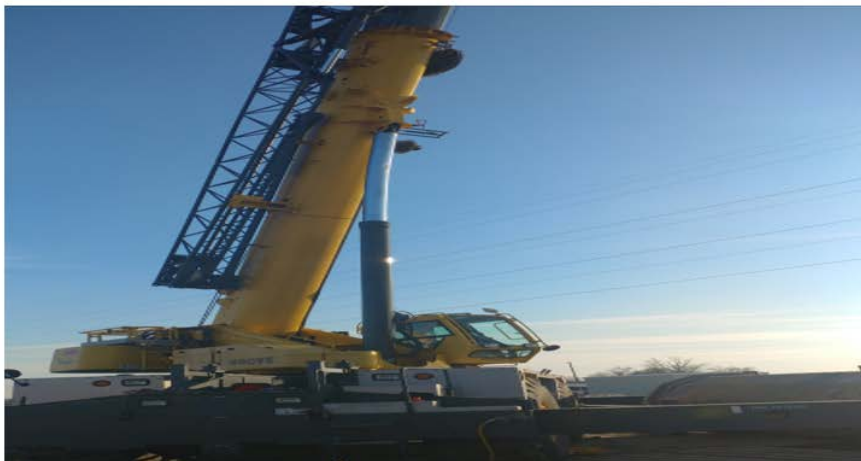
- Extensive damage to crane from 35,000 lb. caisson falling off of rigging and impacting crane.
- Significant injury caused by employee jumping from off-road 150 ton crane onto matting below.

Damage to crane.

- Shut job down for three weeks while the investigation took place and a return-to-work plan was submitted and vetted.
- Ensured that crews had a detailed plan on how to comply with maintaining positive control at all times for all subsequent caissons lifted.
- Sub-contractor changed out previous crew and had management on-site for remainder of work.
- Additional oversight was required at all times by prime contractor and our project management.

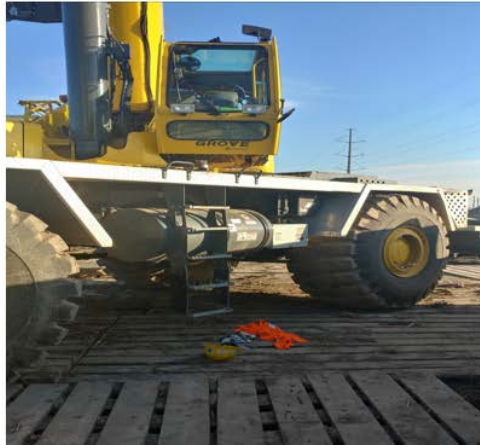
An employee jumped from an off-road 150-ton crane onto a matting below causing a significant injury. The employee jumped because a 35,000 lb. caisson fell from a rigging and landed on the crane, which caused an extensive amount of damage to the crane.

Crane and spot that employee fell onto.

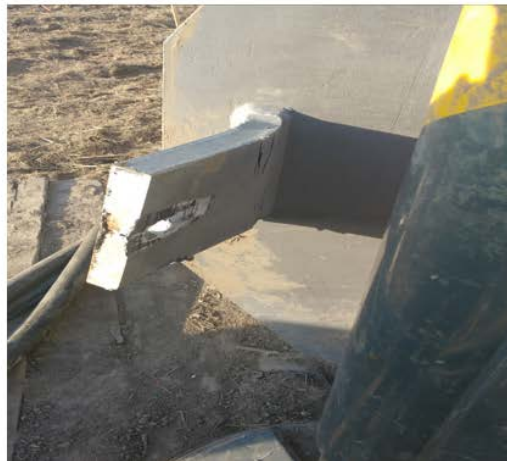
- Deviation from plan allowed crew to use machinery in a way manufacture did not intend and warned against.
- Driving ears on the caisson came improperly coated with galvanizing from the manufacture. This caused the teeth of the vibratory hammer to get fouled by galvanizing.

Galvanizing on caisson ears.

- Ensure moveable and fixed jaw teeth are not worn and allow all teeth to engage the caisson tab.
- Ensure teeth are not corroded or filled with debris.
- Remove galvanized coating if necessary.
- Do not use the vibratory hammer to lift the caisson.
- Do not lift caisson with vibratory hammer teeth.
- Inspect hydraulic lines and fittings prior to use. DO NOT use hands during inspections.
- Do not lift hydraulic lines with steel wire.
- Do not pull or attach tag lines on hydraulic lines.
