NATF Redacted Operating Experience Report

Vehicle Leaf Spring Failure

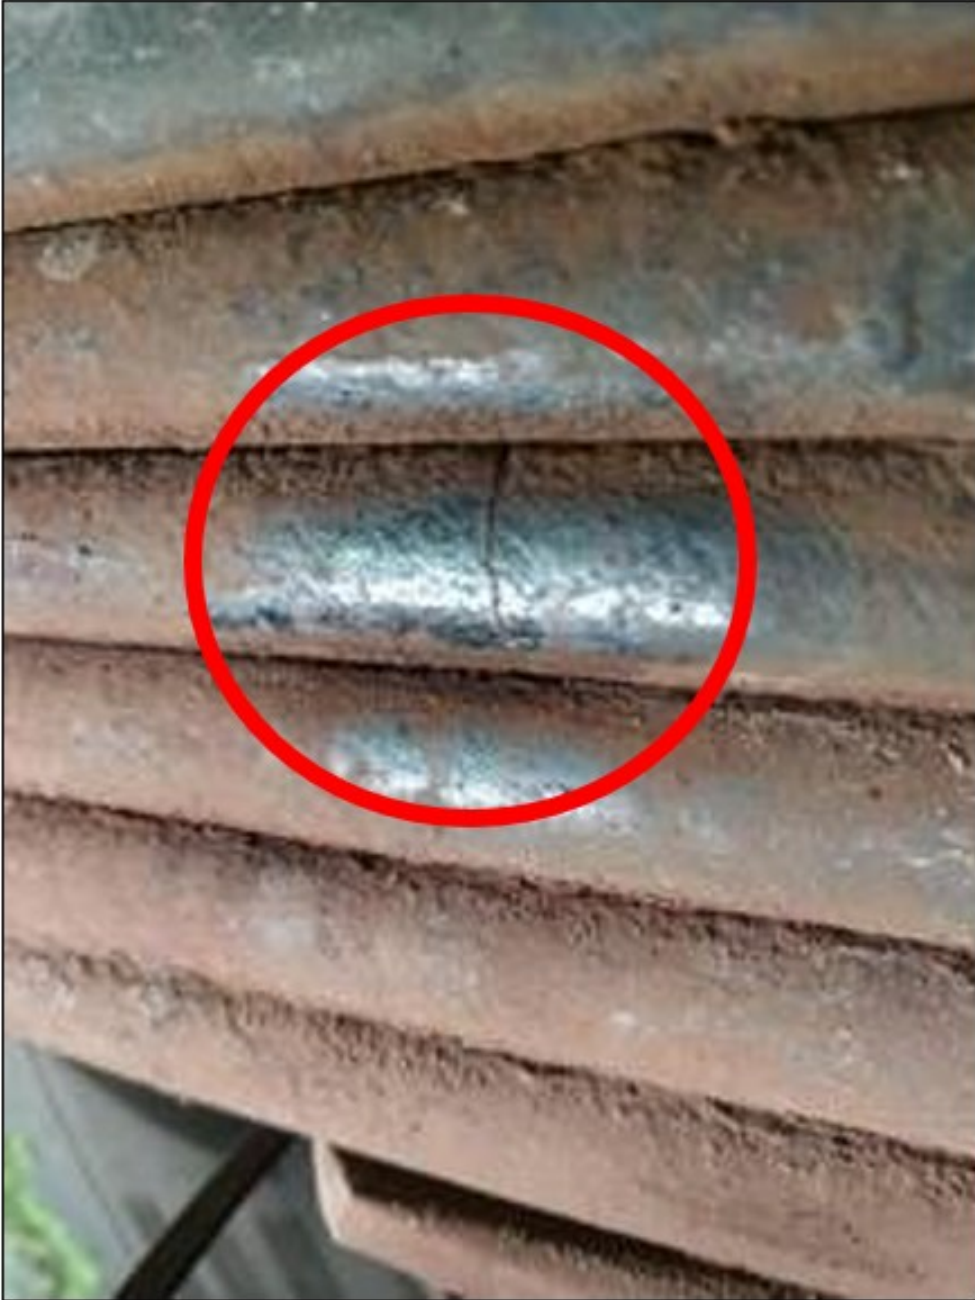
While dumping chips, a vegetation management (VM) contractor crew took a few minutes to inspect and grease the hoist and under carriage of the truck they were using. During inspection, they noticed that one of the leaf springs on the truck was broken. This contractor had been experiencing repeated leaf-spring failures on certain model trucks with an over-center aerial device over a span of several months. These failures led to unsafe situations in which the vehicle was immediately taken out of service for repair.

The leaf-spring failure was found on multiple trucks. Therefore, the extent of this issue is broad, and all vehicles of this make should be carefully reviewed on a continuous basis. See figure 1 on next page.

Figure 1 - Broken Leaf Spring

1. Thorough inspection of all equipment before each use is critical.
2. Equipment issues are not always obvious or easily detectable, and a second set of eyes completing a fit-for-use review can be helpful.

1. The VM contractor reached out to technical support services of the vehicle and over-center aerial device manufacturers. Both entities reported back that they have not received any bulletins, recalls, or leaf failures within a given model year / serial number.
 - a. The vehicle manufacturer did note seeing this when the bolt near the leaf spring hanger is not inspected after the rear chassis gross axle weight rating has been compromised.
2. The VM contractor has resorted to replacing the leaf springs and has raised awareness about this issue across the company.
3. All employees operating this model truck must complete a thorough leaf-spring inspection daily to ensure the vehicle integrity.
