NATF Redacted Operating Experience Report

Bucket Truck Rollover

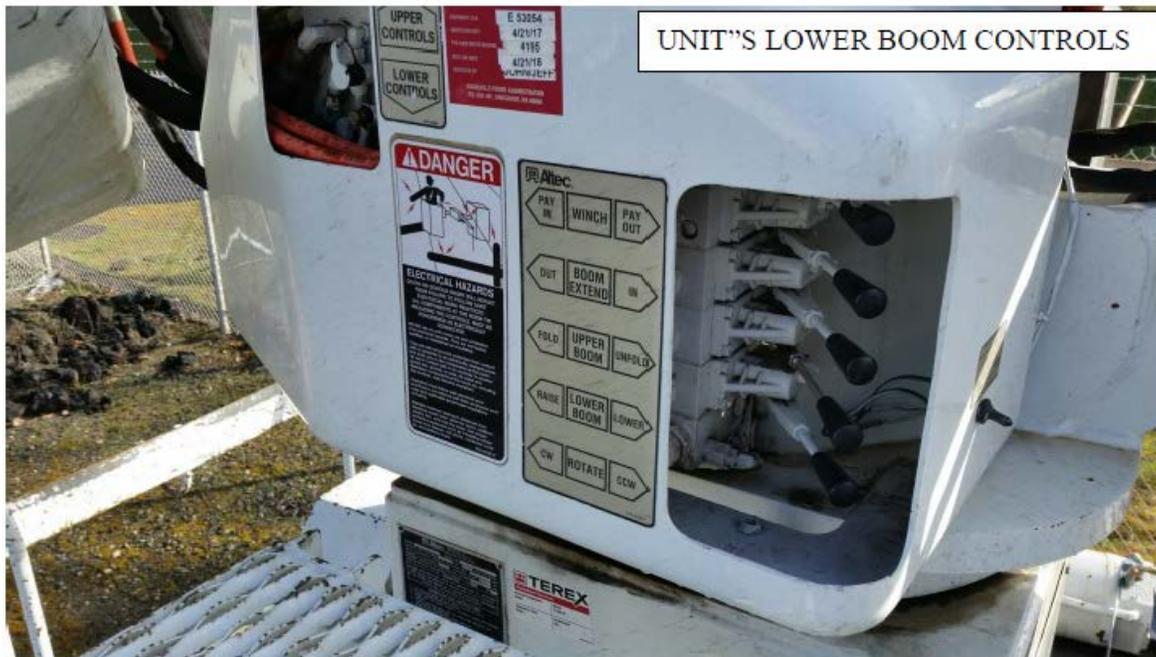
At approximately 19:18, the crew 3 foreman proceeded to the unit's lower controls located on the pedestal of the unit above the truck bed. Before lowering the boom, he realized he did not have the proper PPE and left the controls to retrieve his PPE out of his work truck.

At approximately 19:22, the crew 3 foreman returned directly to the tailboard of the bucket truck following the interruption to retrieve the PPE. Having lost his place in the process and failing to notice the un-stowed boom, he proceeded to raise both high-side outriggers and then continued to the front low-side outrigger. Upon initial retraction of the front low-side outrigger, the crew 3 foreman noticed the truck starting to rapidly become unstable and began rolling toward the low side.

At approximately 19:23, the boom descended toward the low side, contacted two conductors and the fiber line, and pinned them toward the ground. The bucket truck came to rest on to the street side (driver side) with the boom falling across a barricaded paved walking trail, with the upper boom and bucket landing in heavy brush.

5. Design and install interlocks, with manufacturer approval, on all equipment identified in the “Extent of Condition” section below to prevent outrigger retraction when the boom is not fully stowed.
