NATF Redacted Operating Experience Report

Roll Away ATV in Right-of-Way

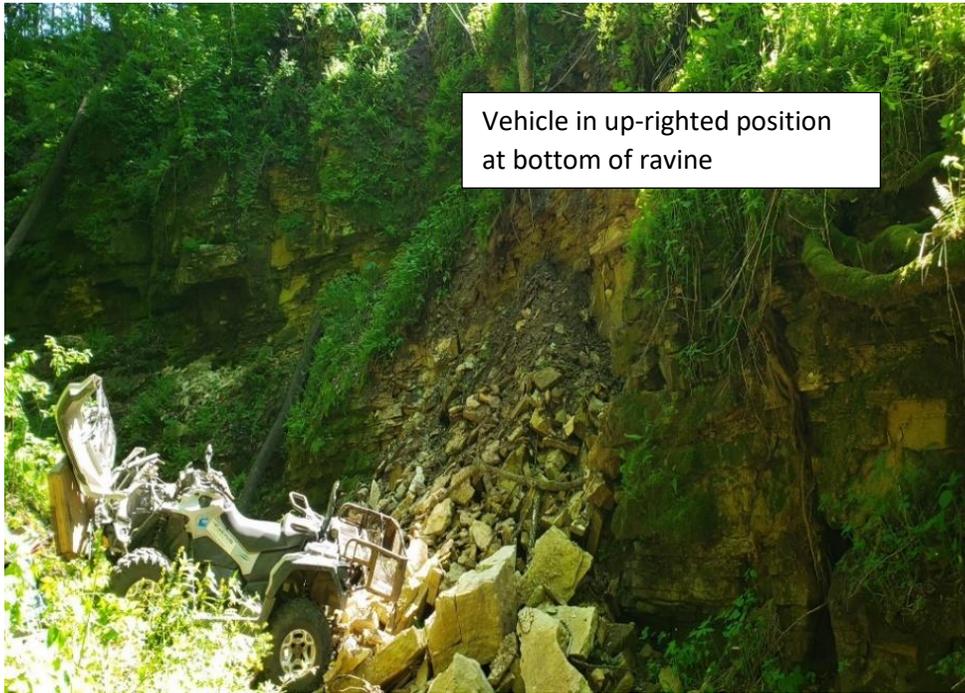
3. The direction with which vehicles are parked on a sloped terrain can reduce the risk of unintended roll, property damage, and personal injury. Parking the vehicle in a direction pointing away from the workers is an important takeaway from this incident.

5. The transmission of this ATV model was noted as being difficult to engage into park, making it more susceptible to or possibly contributing to the ATV coming out of gear and rolling freely. Mechanical maintenance on the vehicle's braking system and associated transmission linkage was current, per company records. The most-recent brake replacement was approximately one year prior to this incident. Per discussion with company mechanics, this ATV model's transmission linkage was known to be challenging at times to engage into park, although the linkage was intact and shifted appropriately when tested after the incident.

View from the top, looking down into the ravine at damaged vehicle
