SUBJECT: NATF Periodic Update to the NERC BOT – August 2014

Attachments: 1. Summary of NATF / NERC Coordination Topics
2. NATF near term focus and activities
3. 345 kV Breaker Status Details (dated July 7, 2014)

Lastly, NERC had requested support and coordination with the NATF and other organizations following issuance of the October 2013 Advisory (Hitachi HVB 345 kV breakers). Per that request, the NATF has coordinated with our members and other organizations to promote awareness of the issue and to provide detailed status of the subject breakers. This effort was extremely successful, resulting in identification of **over 97%** of the subject breakers. Detailed results are contained under attachment 3.

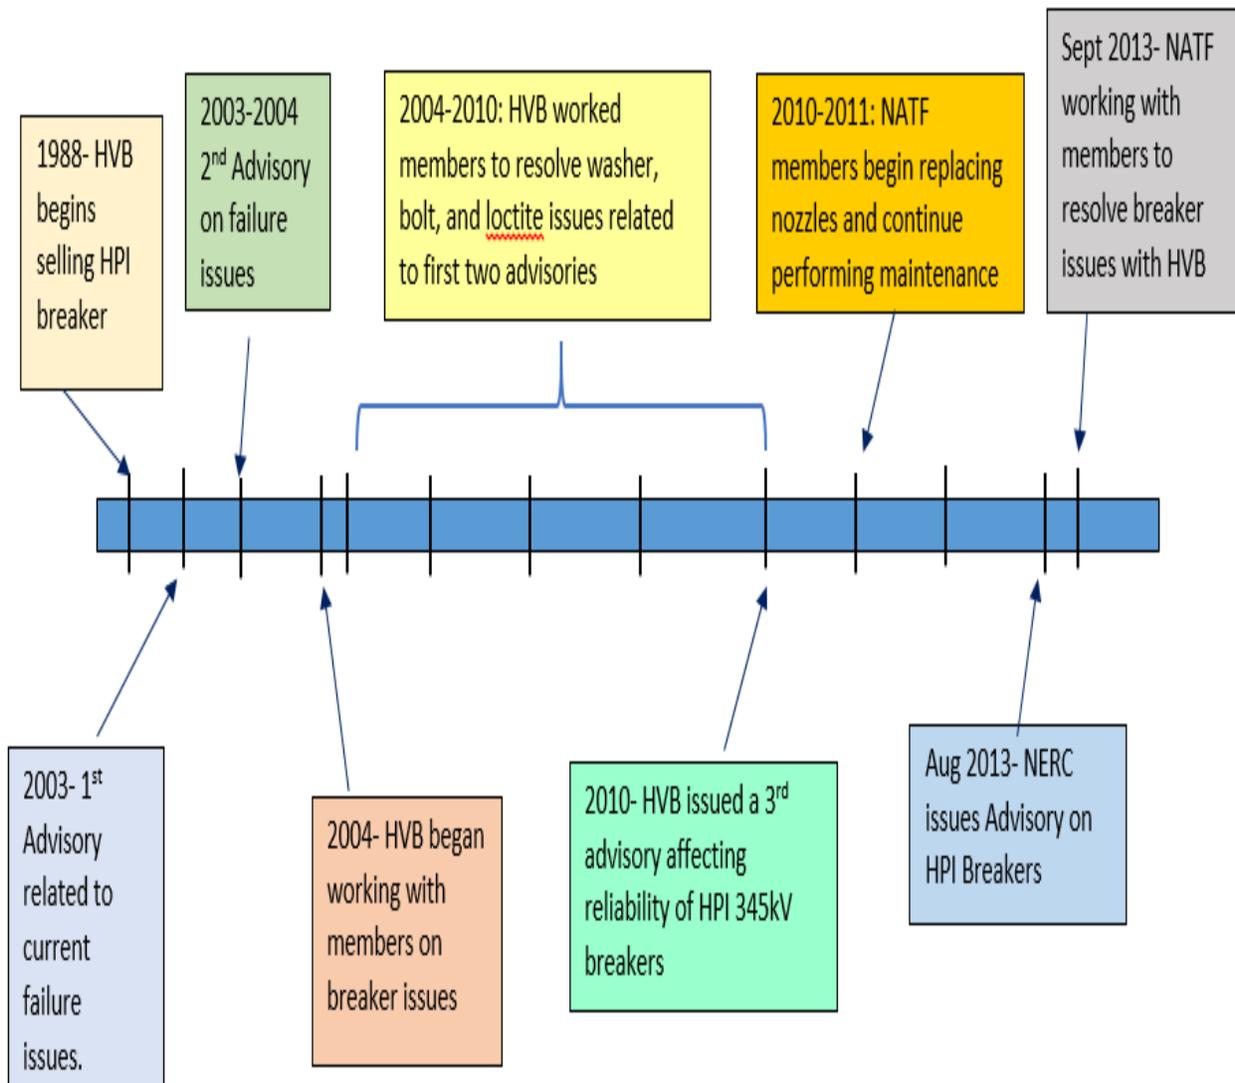
Timeline of 345 kV Breaker Activities with Forum Members

The timelines and charts below provide summary information collected from NATF members and HVB representatives:
