NATF Redacted Operating Experience Report

Cutting DC Cable While Energized

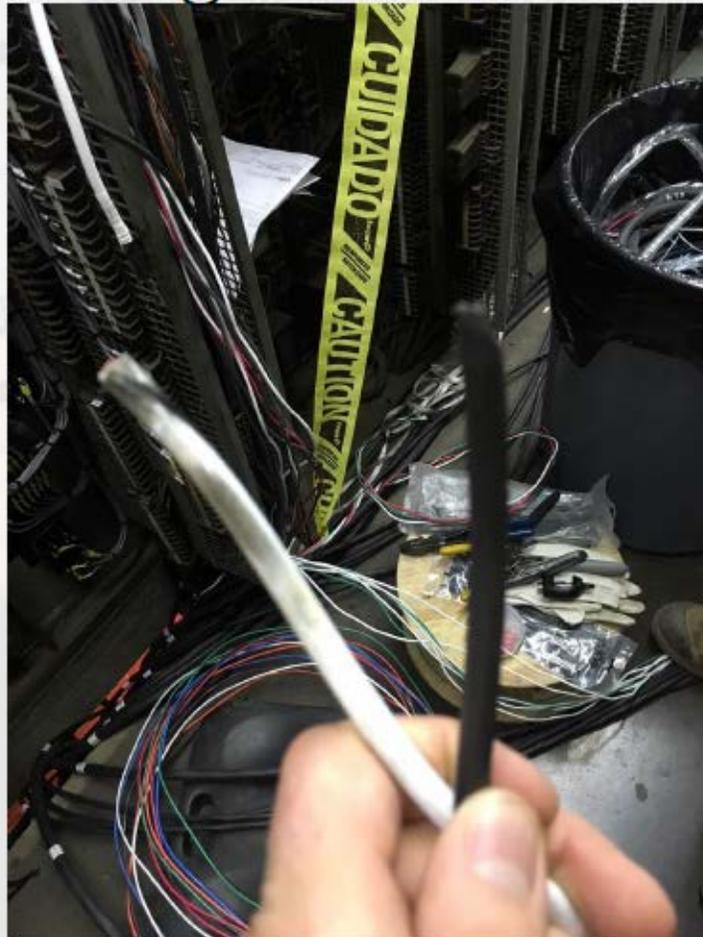
During work on a panel, wiremen were landing the new power supply cable per the design drawing specifications. An arc-flash occurred while cutting the power supply cable. Unknown to the wiremen, the cable had been energized the previous day by a relay testing crew.

Cable wires being cut

1. Use wiring and schematic diagrams to perform wire checks and validate schematics against wiring diagrams.
2. Use peer checks for energizing new circuits.
3. Communicate with all crews involved when changing circuit status.

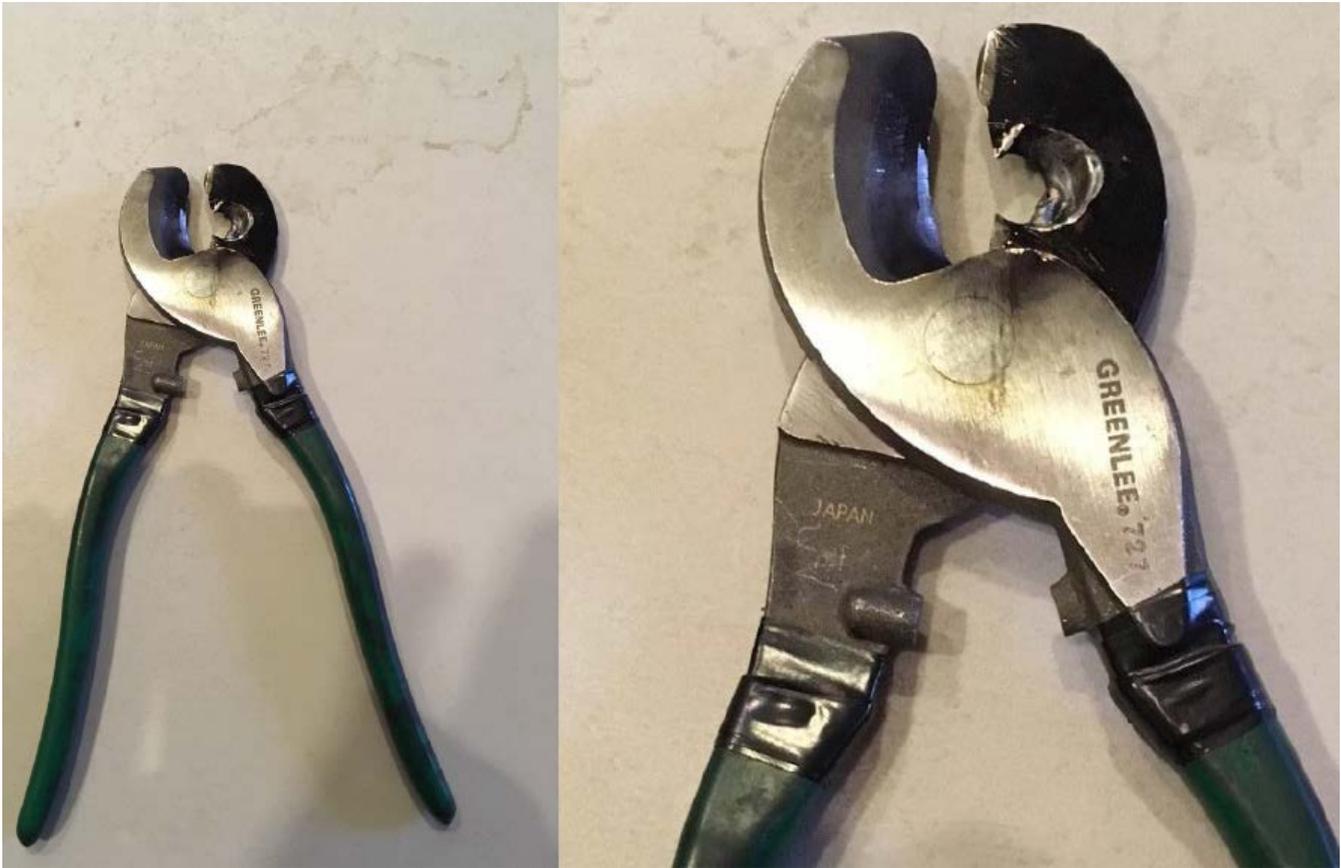
- Crew was wiring a relay and control panel as part of upgrade work.
- While cutting a new two-conductor cable to be used as DC supply to the panel, the cable shorted, causing an arc-flash.
- The arc extinguished, and the crew found the source and deenergized the cable.
- Worker had black marks on his hand but no signs of burns or injuries.

- The day prior to the incident, relay testers proceeded to energize a newly installed relay panel.
- Referring to a schematic, testers verified what components would be energized.
- The schematic they used did not show the new cable that was cut the day of the incident.
- Relay testers did not consult with the commissioning engineer about energizing the panel.
- Relay testers did not verify panel wiring against the detailed wiring diagram.
