# NATF Redacted Operating Experience Report

## Disposable Portable Propane Tank Storage

Disposable portable propane tank storage

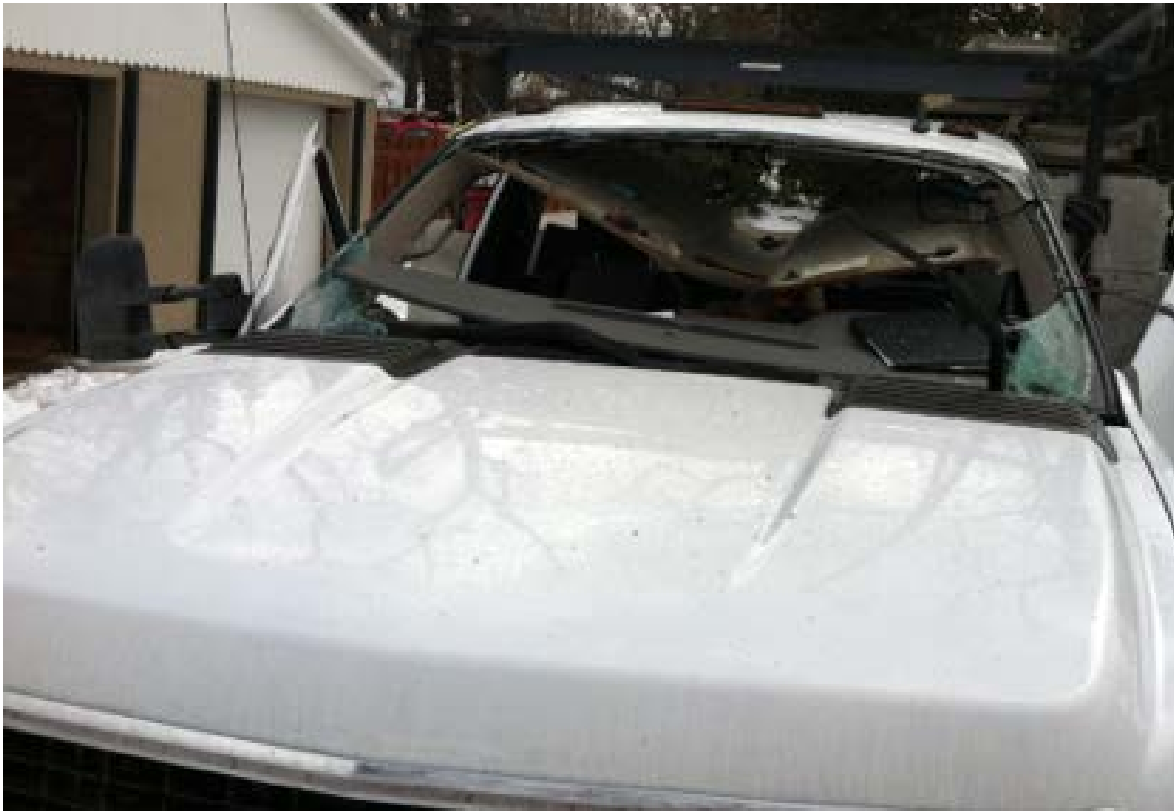
Explanatory photo:

The employee went to his service truck the next morning and opened the cab door. When the door was only partially open, the truck cab exploded. The employee was blown back from the vehicle, the windshield was blown across the street, and the entire firewall and back of the cab were pushed out. There was no fire but the vehicle was a total loss due to the expansion of the cab. The employee was treated for small cuts and bruises but was otherwise unhurt.

Damage to vehicle from a single, hand held, disposable propane tank:

1. Employees were trained on proper, disposable propane tank storage.
2. Required all disposable propane tanks not in use to be capped with a brass cap designed for hand held tanks.
3. Required that any tank stored or transported must be in a ventilated area outside of passenger cabins.

4. Required that all propane cylinders be stored in an upright position.
5. Tanks may be warmed in a truck cab as long as windows remain open.
