NATF Redacted Operating Experience Report

Personal Injury When Lifting Test Equipment

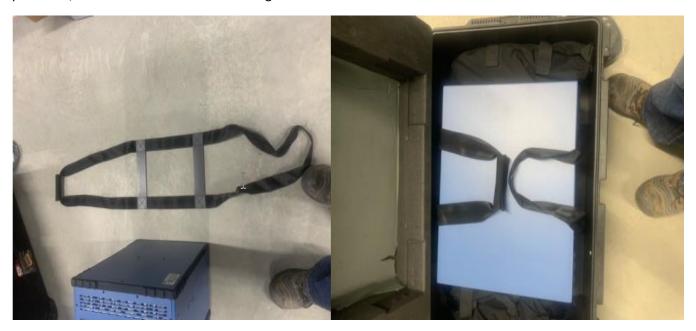
When lifting a test set out of its case, a field worker tore a forearm muscle, resulting in the need for surgery. The test set weighs approximately 50 pounds and requires the technician to reach into the bottom of case to pull it out, which creates an awkward lifting situation.

- 1. Our company needs to reinforce the importance of proper lifting techniques and hazard identification (need to provide additional training).
- 2. We learned that the manufacturer provides, as part of its new test sets, a lifting strap, which makes the lift easier and less awkward.

1. Lifting straps were ordered for the company's test kits.

- 2. Additional lifting training will be provided.
- 3. Currently evaluating other test-equipment manufacturers.
